## "About the House"

Inspection #: ----13128

Date: /2019

**AmeriSpec****GENERAL CONDITIONS**

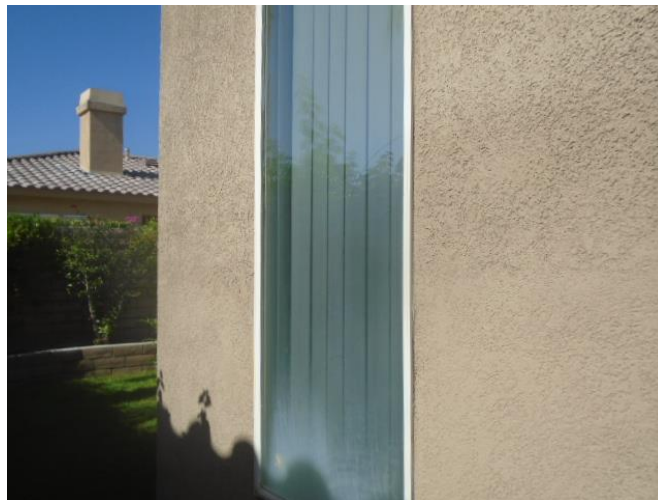
1. Fixed panel window at left side in the master suite is broken.

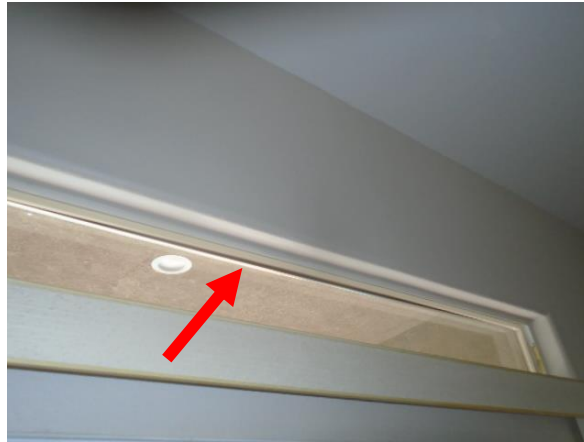
2. Displaced seal observed at transom window above slider.

Monitoring for any condensation is advised.

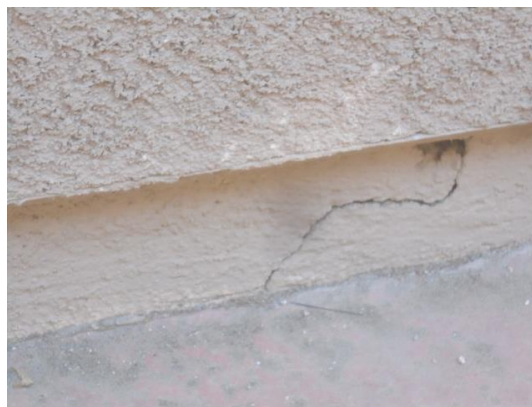
1116. Foundation

A crack was observed at left side behind the garage. No visible evidence of transference in structure. Cracks are not uncommon in expansive soils

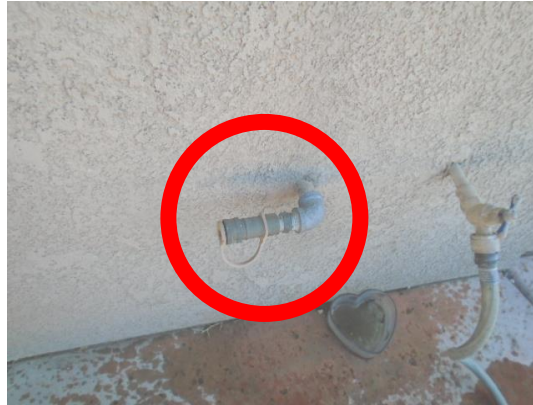
1120. BBQ

**Review.** Missing gas valve. We advise plumbers review for installing gas valve as required for safety.

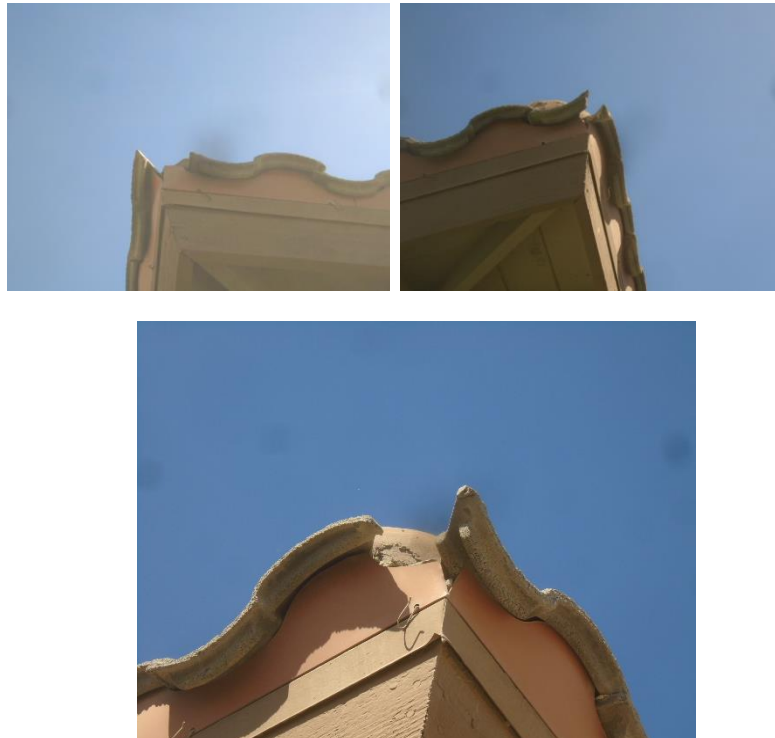
**1.** Gaps at mired outside corners will allow water entry.  
This appears to have been an original and improper installation.

We advise review for repair and evaluation of areas not clearly visible to the inspector, by a licensed roofing contractor.

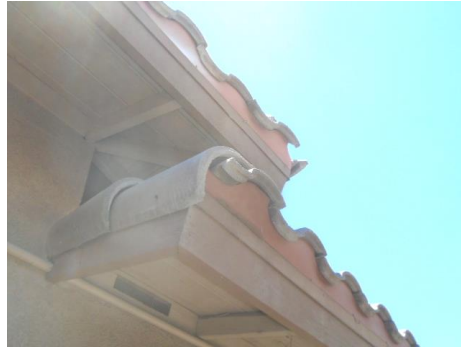
2. Several tiles have slid from original position. This can expose the waterproof membrane to solar deterioration.

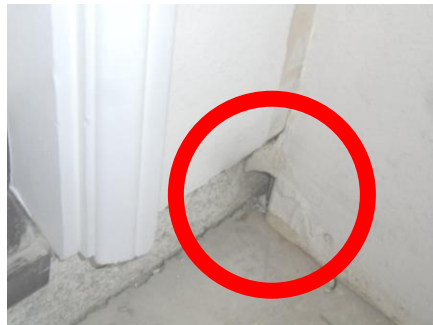
We suggest sealing these gaps as necessary, to restore the fire rating.

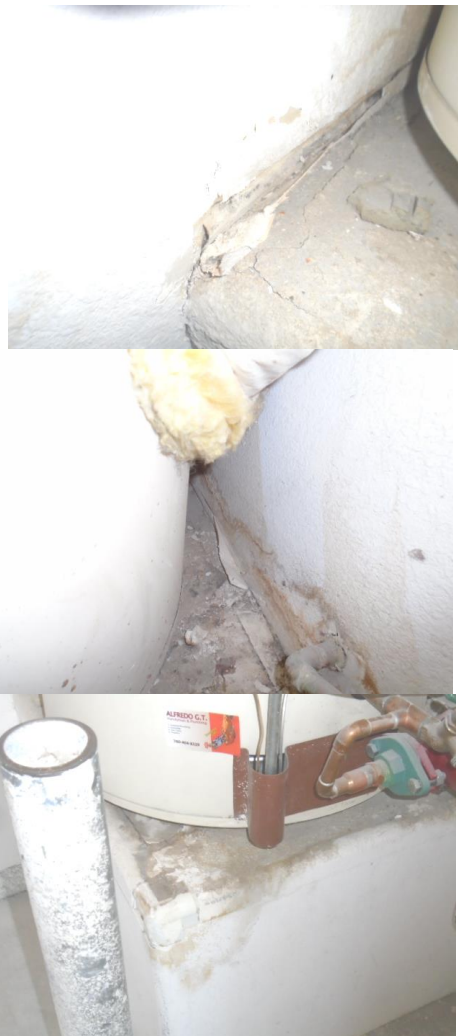
## 1314. Walls

**Review.** Water damage with related fungal residue was observed at water heater platform.

We advise removal of all damaged materials, disinfecting the area and replacing as new. This will require removal of the water heater to properly access damaged materials at wall and platform.

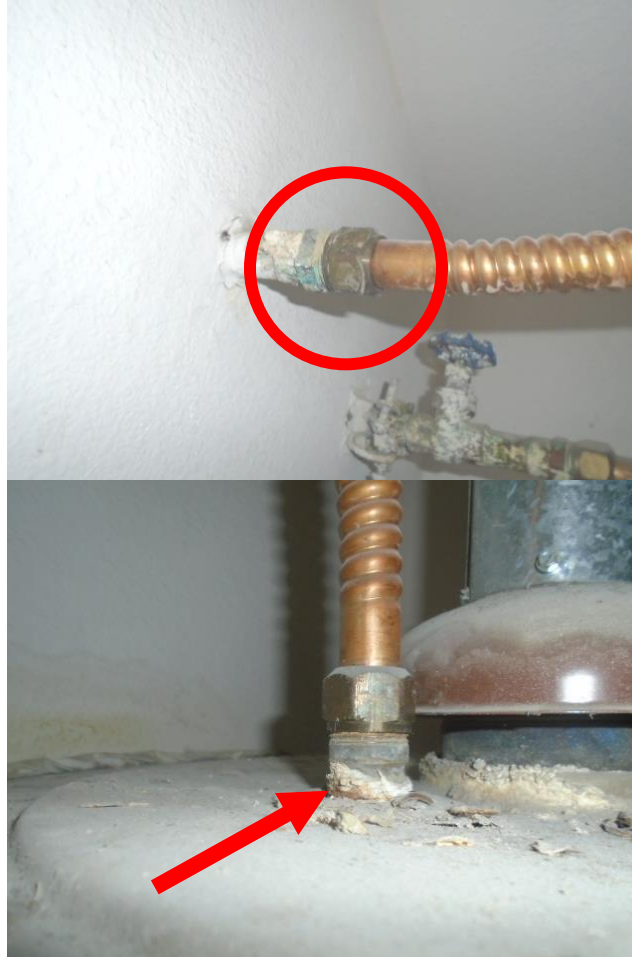
1. Corrosion, rusting and leaking was visible at the fittings at the water heater at the time of inspection.

We advise review by a licensed plumber for repair or replacement, as necessary.

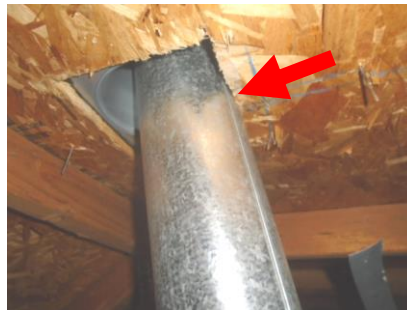
1903. Exhaust Venting **Review.** The left side heater vent pipe is in contact with roof sheathing

A one-inch minimum clearance from combustible material is required.

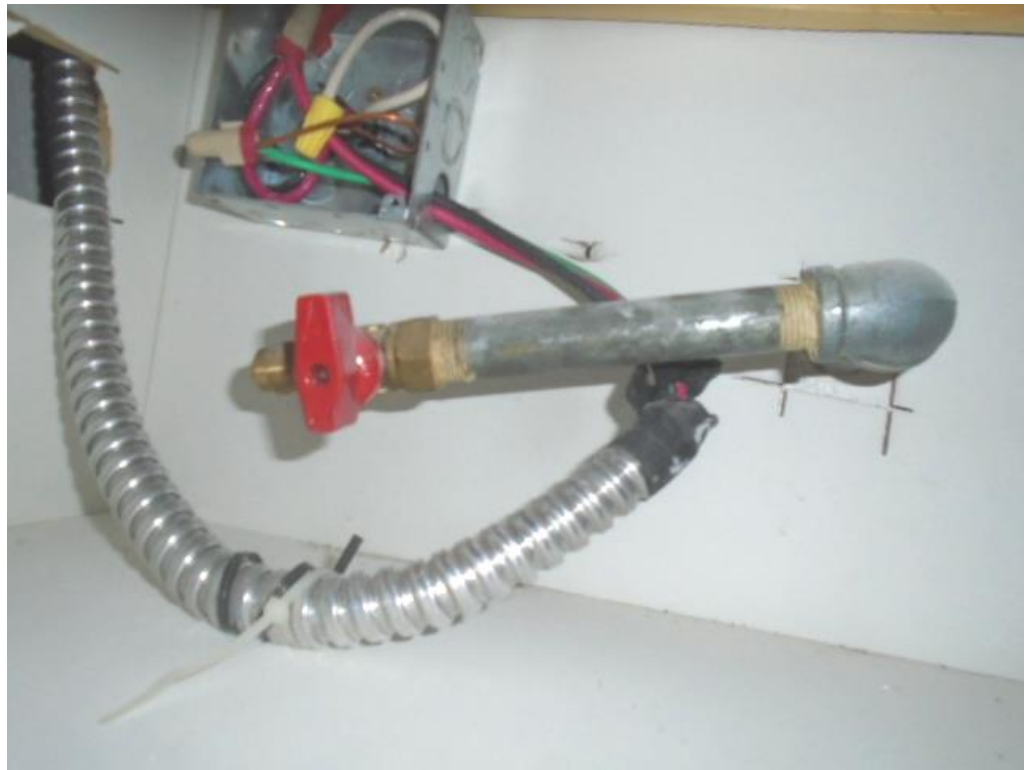
**1.** Wiring for stove and oven is not installed properly and is a safety concern. Wires should be secured in the available conduit to the junction box and a blank cover plate should be installed.

This indicates non-professional installation and should be reviewed and repaired by a licensed electrician.

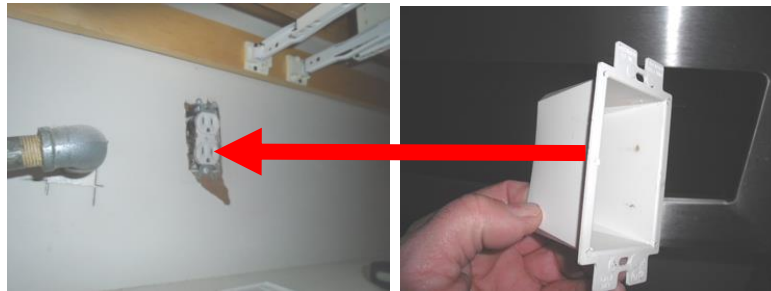
2. Outlet located in cabinet at right side of the stove is improperly installed outside its junction box and is at or near contact with combustible material. This is usually a cabinet installer's defect.

We advise electricians review for installing a tapered junction box extension or for enlarging cabinet back to allow outlet and cover plate to finish with drywall as originally installed.

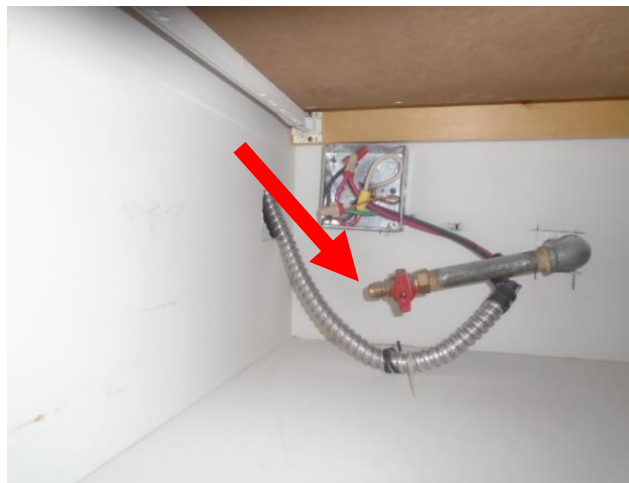
2315. Stove/Cook Top

**Review.** Installing cap at gas valve in cabinet is advised for safety.

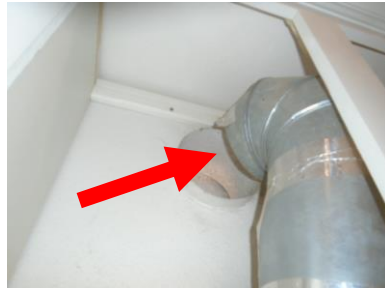
2317. Hood/Fan

**Review.** Exterior vent not connected.

We advise proper installation of vent to available exterior vent.  
To ensure proper venting and for efficiency.

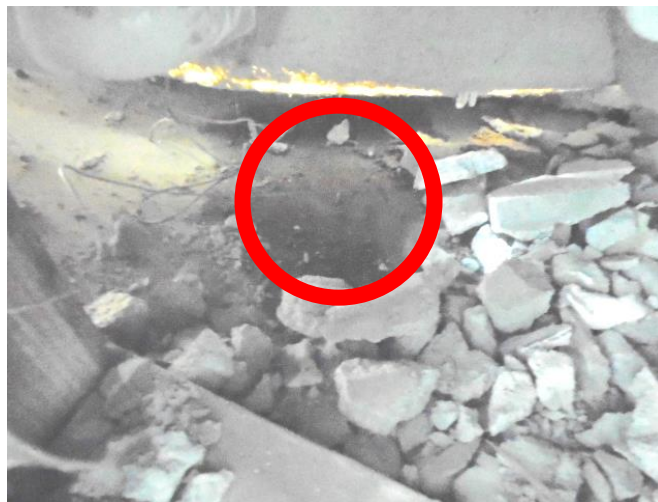
1. After filling the tub, water was observed inside the access panel.

The inspector is unable to determine source.

Plumbers review for repair is advised.

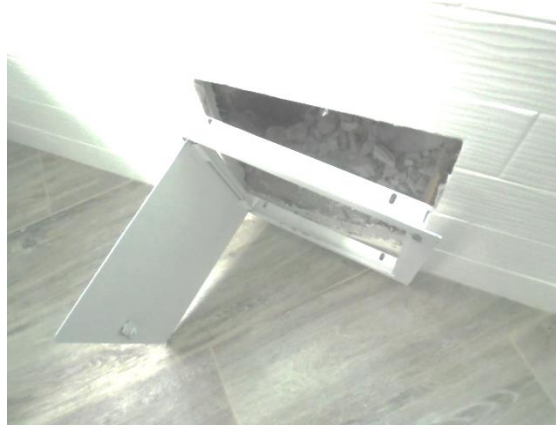
2. We advise securing interior access panel for safety.

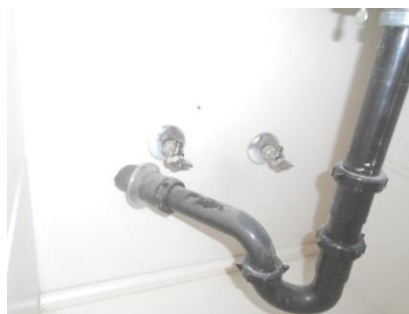
**Review.** Water supply is not connected.

Plumbers repair is advised.

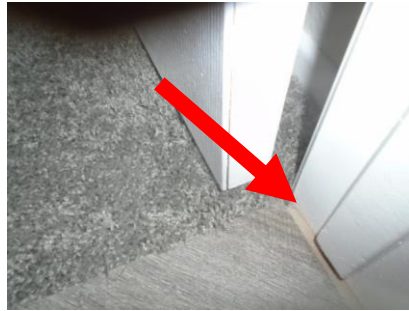
2604. Doors

Panel at door at left front bedroom is loose.

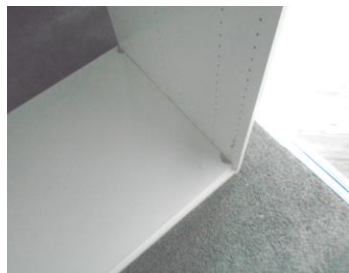
2610. Closets

Damaged shelf board observed in the master bedroom closet.

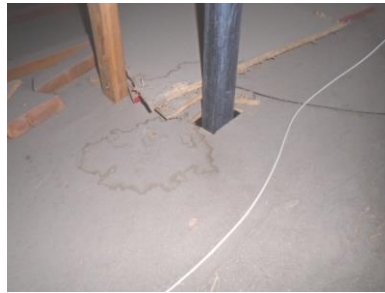
2704. Evidence of Leaking

**Review.** Water stain below sewer vent at left side of access observed.

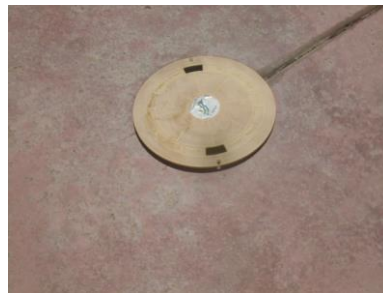
1502. Walkways

**Review.** Cover at cleanout skimmer does not fit flus. Review and repair for safety is advised.

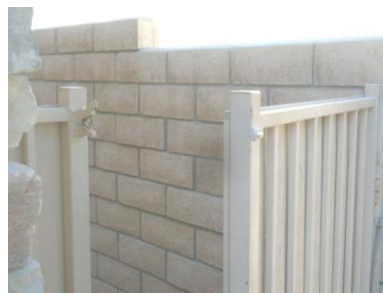
1506. Fences/Gates

**Review.** Auto closing springs at both need more tension to ensure gates close and latch without assistance.

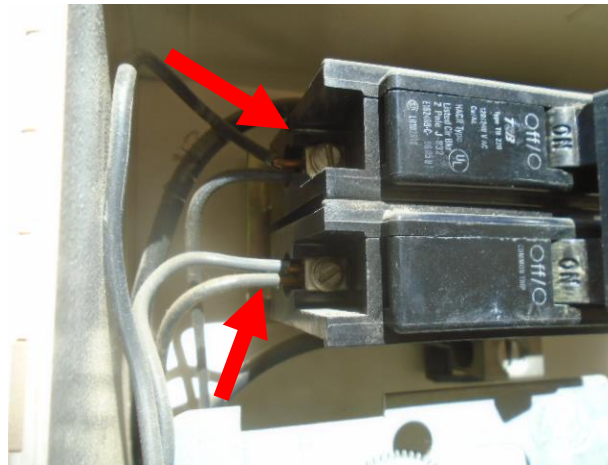
**Review.****1. Double tapping observed at two breakers.**

Double tapping (i.e. 2 wires on a single pole breaker) can add to the load of the affected circuit causing a possible overload and tripping breakers or result in loose connections and overheating of the breaker or connections.

This indicates non-professional installation.

As this represents a safety concern, we advise a review by a licensed electrician prior to close.

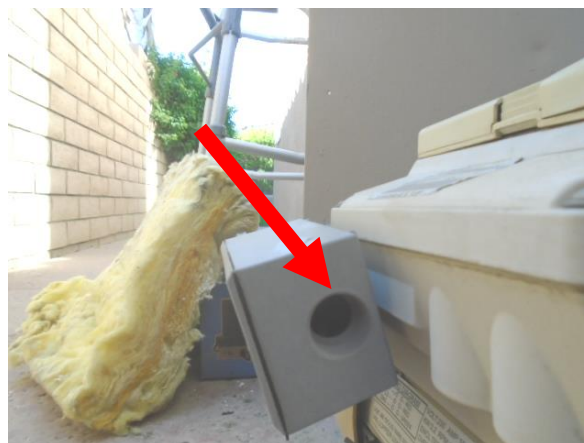
**2. We advise installing a screw in plug at the junction box as required.**

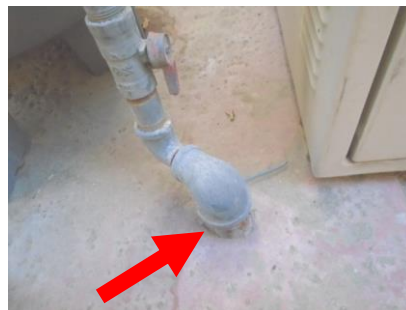
- Removing concrete from contact with gas piping at the ground level is advised as a slip joint is required for seismic safety.
- IRC # 26003.3 and UPC # 313.2

"Provide for expansion and contraction"

Review. Located at the left side of garage. No slip joint provided at pool heater piping.
