## **AmeriSpec Inspection Services**

## AmeriSpec General Home Inspection

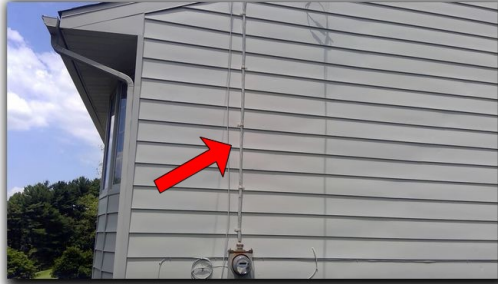
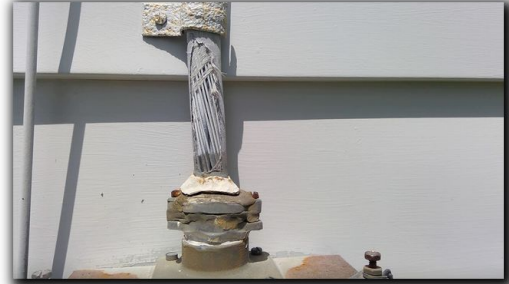
**The service entrance cable is frayed and deteriorated. Correction of this condition is important for safety and to prevent damage from water entry into the main panel/breakers. The local utility company should be consulted.**

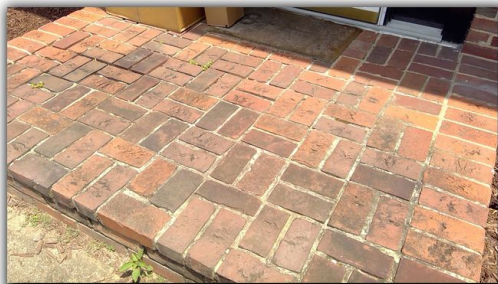
**Deteriorated mortar joints were observed. We recommend re-pointing the affected area to reduce the potential for water infiltration into the structure.**

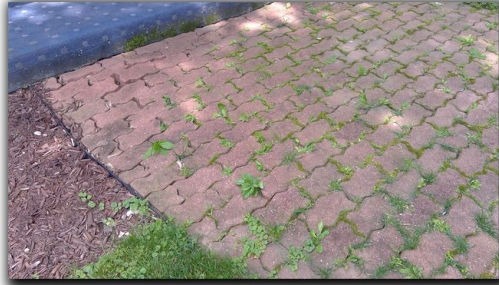
**Settlement was noticed. This is an indication that the base may not be to the proper depth or that settlement has been caused by exterior grading and ground water issues.**

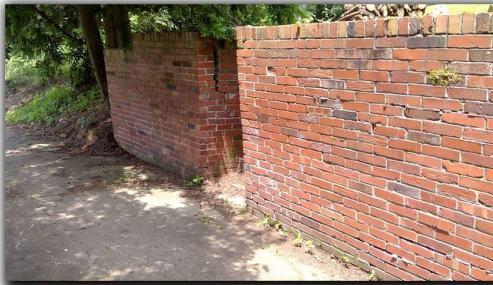
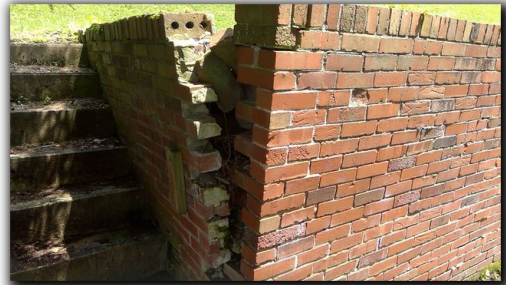
**The retaining wall has leaning, deteriorated and bowed areas. Recommend repair or replacement as necessary to preserve its life span. Adding drainage, tie backs and corrections to grading will also extend its life.**

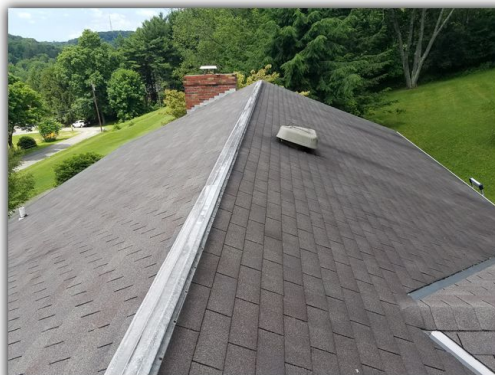
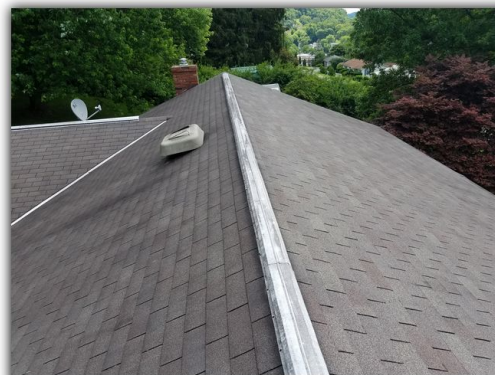
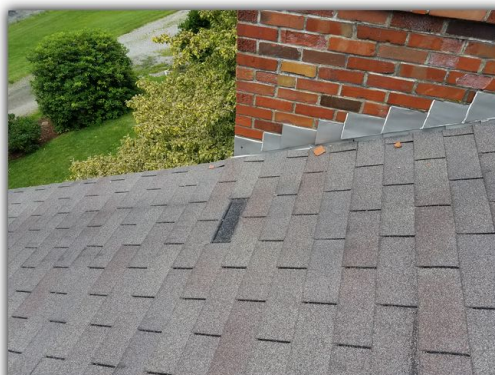
During our general review of the roofing materials it was observed that the roof had damaged/torn materials at the front. The roof should be reviewed by a roofing contractor for necessary repairs.

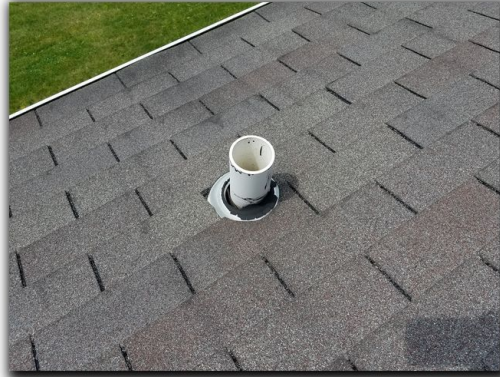
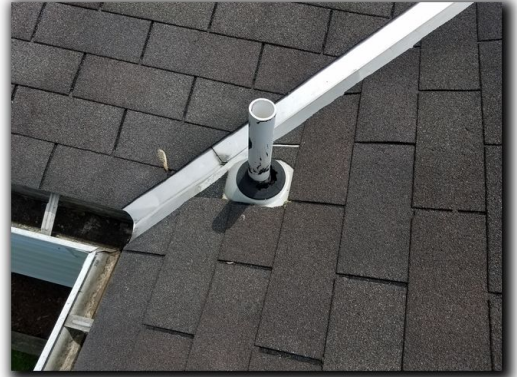
| 3. | <b>Vents/Plumbing Stacks</b> | <h3>2. <b>Repair/Replace:</b></h3> <p>The plumbing vent boot is deteriorated, which may allow water penetration. Re-sealing will provide more permanent water control at this area.</p> |

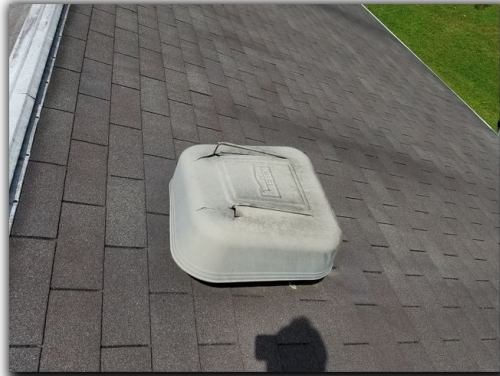
The attic fan cover is deteriorated or damaged, which may allow water penetration into the attic. Repair or replace as necessary.

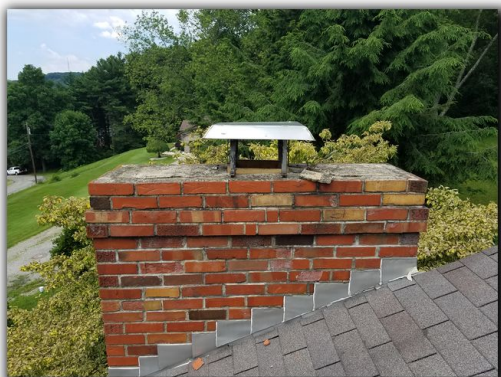
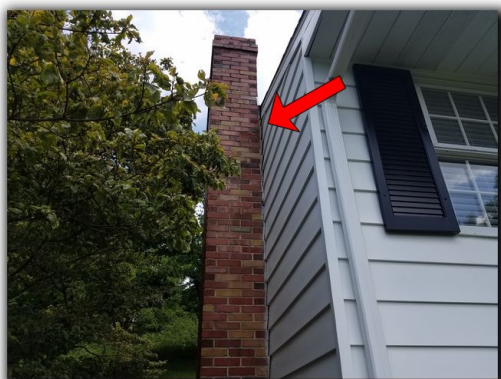
The Chimney has an opening between the masonry and main structure. This is an indication that the footing of the foundation is not at the proper depth, that it is experiencing settlement or otherwise failing or that it was intentionally constructed in this manner. This type of issue should be reviewed by a chimney specialist for necessary corrections.

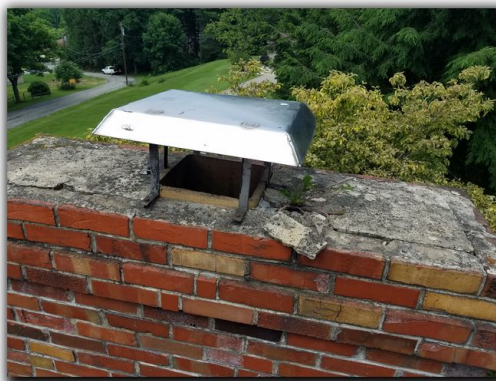
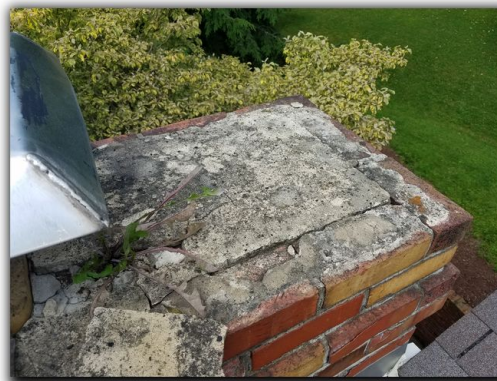
**Suggest repairing/re-building chimney cap/crown to reduce opportunity for water infiltration and damage. Openings, cracks or holes in the chimney cap will collect water and crack mortar during freeze thaw cycles. This is a common maintenance item that is often neglected by homeowners. It should be made a part of the routine seasonal maintenance checklist.**

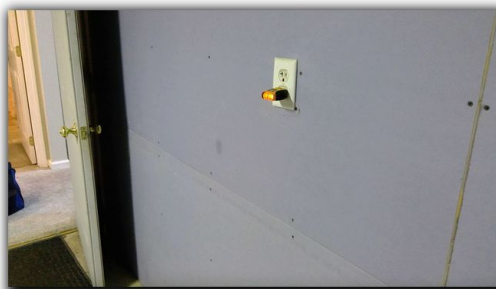
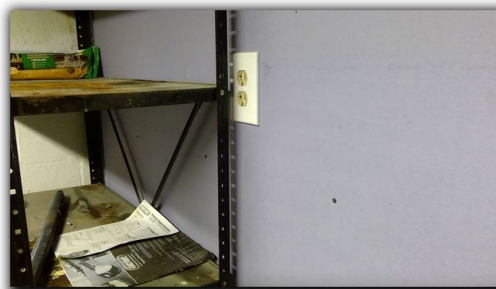
3.	Garage Door Openers	The garage door opener is manufactured by: Genie The door is a roll up-panel.
4.	Fire Door	The fire door material is: Metal
5.	Electrical System	<b>GFCI Not Present:</b> Ground Fault Circuit Interrupter (GFCI) protection is not present. Receptacles near water sources should be grounded. This may not have been required when home was built. Recommend a qualified electrician install (GFCI) outlets as a safety enhancement.

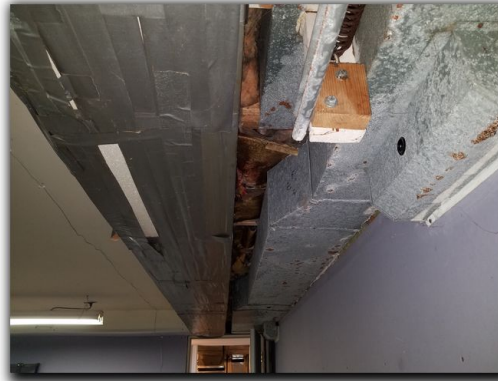
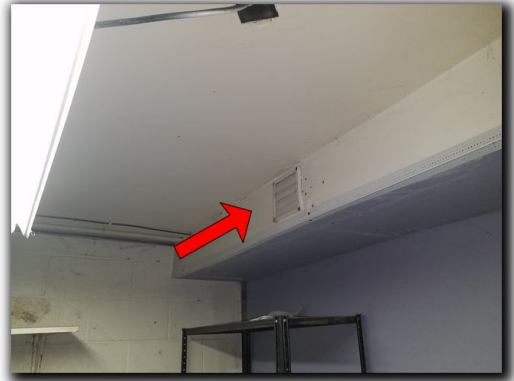
| 7. | <b>Fire Barrier</b> | <p><b>1. Safety Issue:</b><br/>The walls/ceiling adjoining the house have openings into the living area. This compromises the fire barrier. Areas that open into the house should be sealed or otherwise repaired to prevent vapors or fire from entering the living area.</p> <p><b>2. Safety Issue:</b><br/>An open air duct was noticed. This could provide a path for fumes from the garage to enter the heating system. Recommend sealing. The garage should be separated from living space. This would include providing a vapor barrier to prevent fumes from entering the living area.</p> |

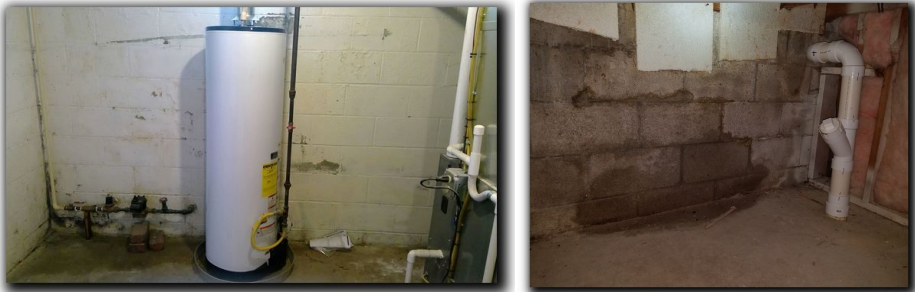
Item	Element	Comment
1.	<b>Floor Comments</b>	Concrete: Common cracks were observed which is primarily a cosmetic concern.
2.	<b>Wall Comments</b>	<b>Efflorescence was observed at the front, back and right walls. Efflorescence is a mineral deposit left behind from exterior water infiltration. This is usually prevented or reduced by reworking exterior groundwater (diverting water away from the structure). Recommend consulting Sellers as to moisture problems.</b>

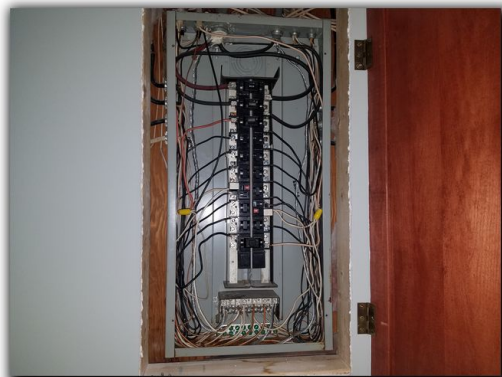
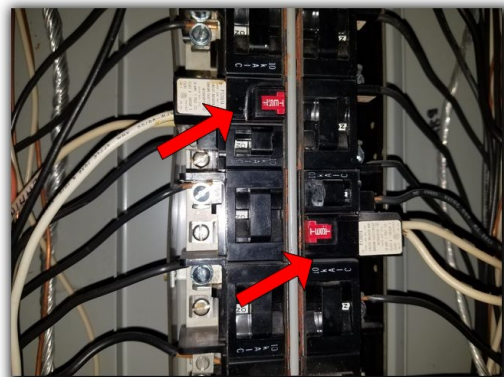
| 1. | <b>Electrical Panel Condition</b> | <b>1. Repair:</b> Double tapping was observed. Double tapping (i.e. 2 wires on a single pole breaker) can add to the load of the affected circuit causing a possible loosening of lugs, overload and tripping breakers. Currently manufactured breakers that allow 2 wires to be terminated at the breaker are Square D Q O type and Cutler Hammer CH type. Recommend professional repair as necessary. |

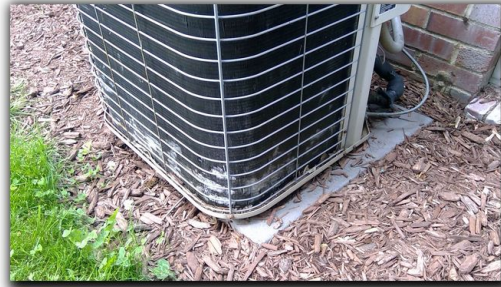
| 6. | <b>Comments</b> | A standard home inspection does not include evaluation of the adequacy or capacity of the cooling supply systems.<br><b>Maintenance:</b><br><b>The condenser fins have excessive oxidation present. Recommend professional cleaning to ensure adequate airflow and operation.</b> |

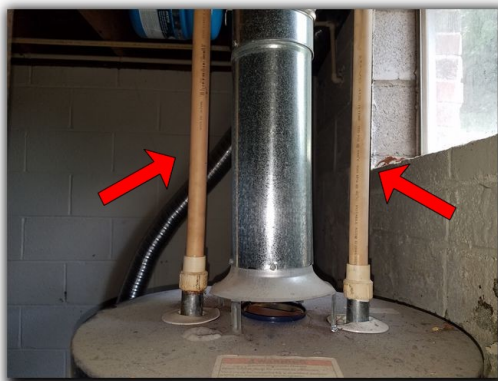
Item	Element	Comment
1.	<b>General Conditions</b>	The evaluation of the water heating system is both visual and functional, provided power and/or fuel is supplied to the unit. It is tested using normal operating controls. <b>Energy Source: Gas</b>
2.	<b>Combustion Chamber &amp; Gas Supply Line</b>	Unit was tested and operated properly.
3.	<b>Supply Lines</b>	Supply lines were checked for leaks and overall condition and appears serviceable.
4.	<b>Exhaust Venting</b>	The venting system was visually inspected and tested for the presence of carbon monoxide. <b>1. Repair/Replace:</b> <b>Plastic CPVC piping should start a minimum of 18 inches from the top of gas water heaters. This is due to the vent clearance requirements. Plastic CPVC/Polybutylene supply lines may melt due to vent line heat..</b>

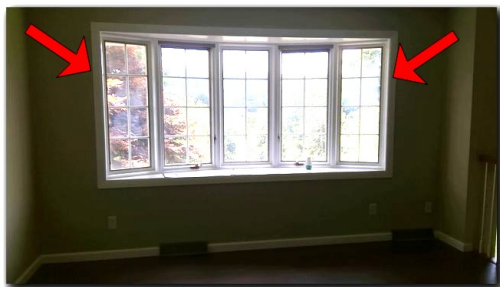
4.	Windows	<p><b>Window Comments: Single-pane</b></p> <p>The windows are an older style single pane window. Single pane windows are present at all or several areas. Older single pane windows are more likely to have missing or compromised weather stripping and hardware that is in poor condition. These defects may not be detailed in the report.</p> <p><b>1. Repair/Replace:</b></p> <p><b>Fog and condensation were noted in the double glazed insulated window panes. This indicates a broken seal which will reduce visibility and the insulating capability of this window. To restore visibility and regain the insulating capability, replacement of this window pane is required.</b></p>

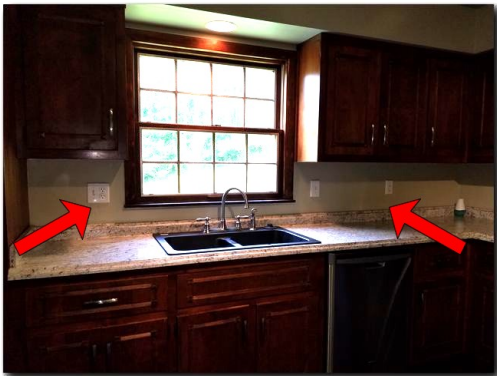
3.	Windows	The windows appeared to be serviceable.
4.	Electrical	<p><b>GFCI Not Present:</b> Ground Fault Circuit Interrupter (GFCI) protection is not present. Receptacles near water sources should be grounded. This may not have been required when home was built. Recommend a qualified electrician install (GFCI) outlets as a safety enhancement.</p>

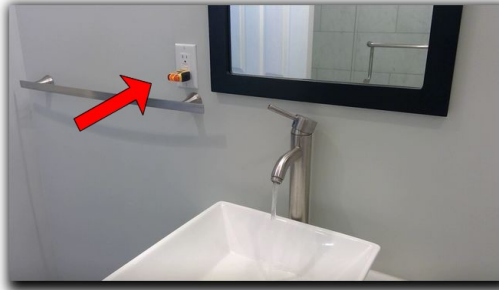
Ground fault circuit interrupter (GFCI) had power when tested. This is often the result of mis-wiring and is usually easily fixed. Advise repair or replacement as needed.

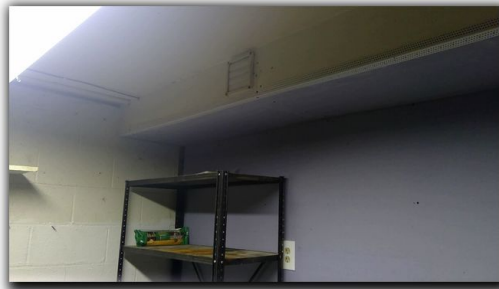
Exhaust fan is not exterior vented. Suggest extending the vent duct to the exterior for **proper** ventilation.

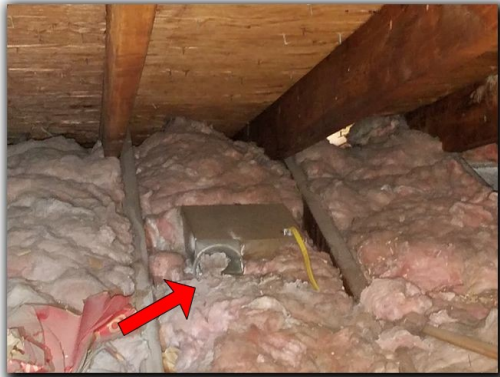
Bathroom vent fan is venting into the attic. Trapped moisture backs into the attic and may present problems such as wood deterioration or fungal growth. Recommend extending fan exhaust to the exterior to prevent damage and/or deterioration from moisture and/or condensation.
