Amerispec Home Inspection

INSPECTION CONDITIONS

Crossville, TN 38558.

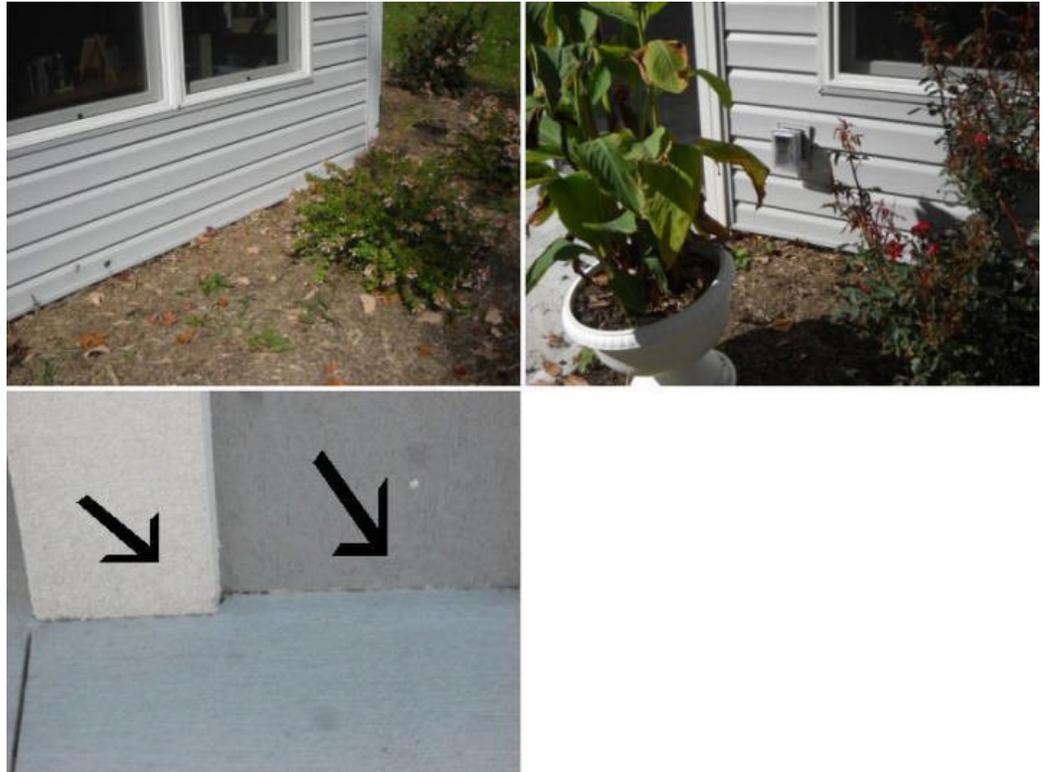
Vinyl Siding: appears serviceable.

Siding is too close to grade, especially the right rear and sections of the front to the right of the garage. All types of siding should not be any closer than six inches above finish grade. Proper distance will help prevent deterioration to the surface and moisture entering the house and insect infestation.

Recommend sealing all through wall penetrations as part of routine maintenance, especially near the electric meter. (See the Home Repair Manual)

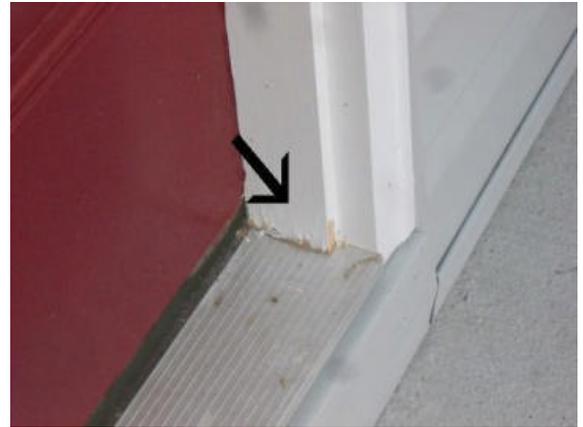
Appears serviceable.
Recommend painting and preserving
the front door lower trim and frame.

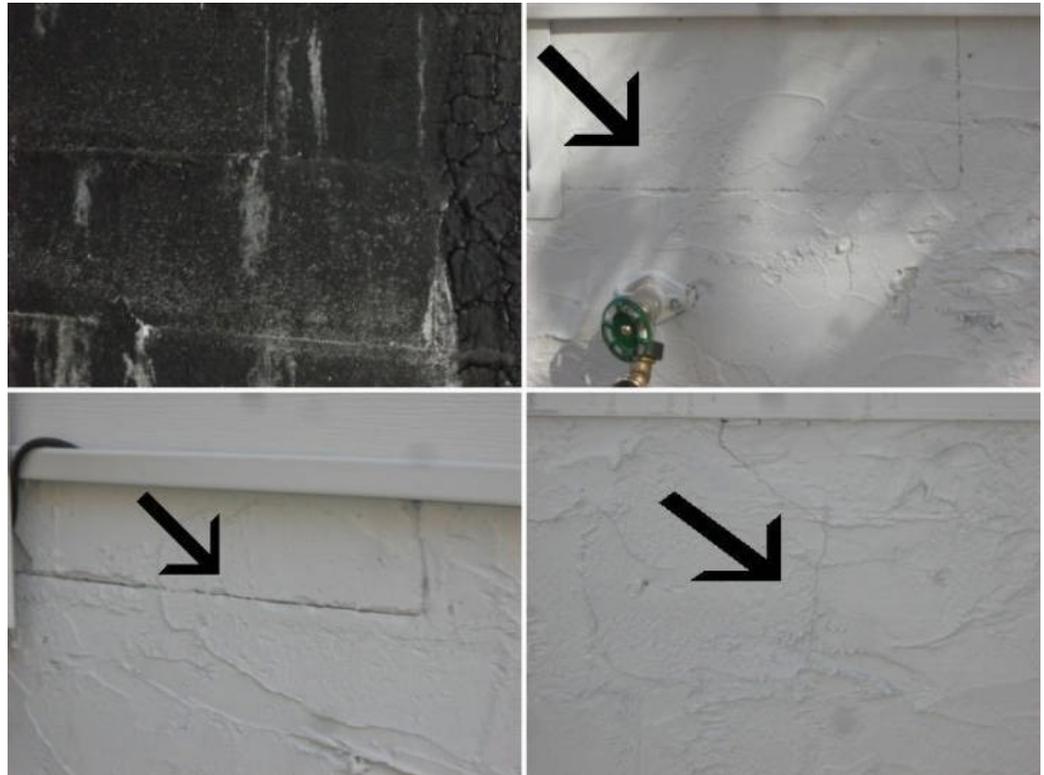
Waterproofing on walls prevents full viewing.

Normal settlement step cracks and other normal settlement cracks observed at several locations, especially near crawl space vents and at garage slab. Not significant at this time, recommend monitoring. Re pointing (repairing mortar)/sealing these cracks are recommended to prevent moisture penetration. This should be considered part of routine maintenance.

Efflorescence(mineral deposits) noted on concrete, especially front walls. This is usually a sign of past water penetration. See the header of this section for additional information on moisture in the crawlspace/basement. See grounds section for more details on grading. (See the Home Repair Manual)

Possible leakage from overflowing vent wells seen along front foundation walls in crawl space. The client has elected to have the vents sealed on the inside by insulation panel. See the Ventilation section below for more details.

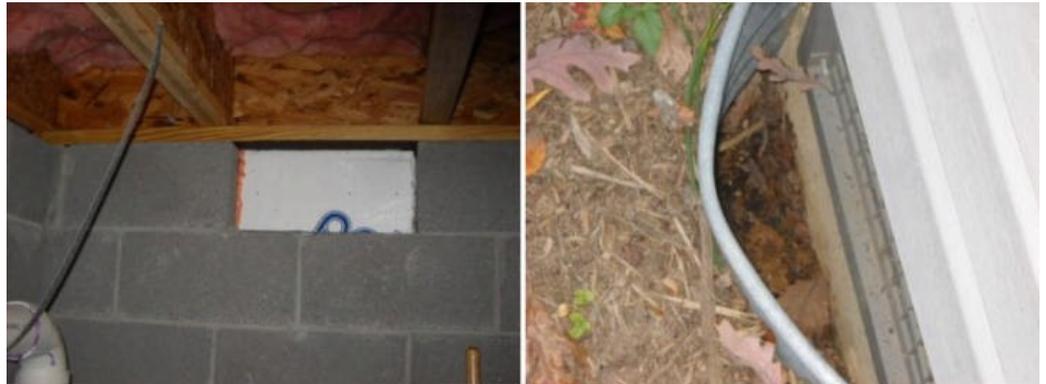
2 vent wells are below grade, recommend periodic monitoring to ensure they are kept free of debris and well drained to minimize water entry into crawlspace. There is evidence that water has overflowed these wells and entered the crawl space. The client has elected to have all vents sealed on the inside and a dehumidifier installed. this is not recommended. Normally if it is decided to create a sealed crawl space it is completely sealed by a contractor with a 100% sealed vapor barrier extending up the walls and columns and with conditioned air supplied to the crawl space. Since the client has elected to seal the inside of the 2 vents with vent wells, he may consider having a contractor remove these vents entirely and seal up the crawl space block foundation walls and remove the wells on the outside to minimize water entry.

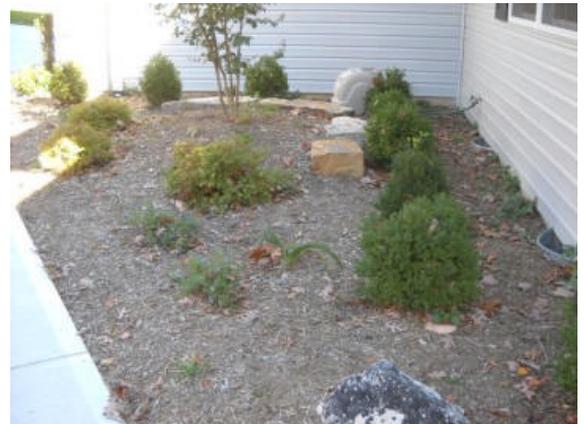
The grounds to the right of the front entrance and outside the front bedroom may not be sloped properly. There is a low spot directly against the foundation wall to the right of the front door. The client may wish to verify proper drainage in a heavy rain and if necessary install a swale. Recommend re-landscaping if necessary.

minimum of 1 inch per foot and extend at least 10 feet away from the foundation. If re sloping the grade is not possible we suggest installing drain tile around the perimeter of the home to aid in proper drainage (some homes already have this drain). Another option would be to add a swale to allow water to drain off to a remote location. This is needed to help ensure a dry crawlspace/basement. We also suggest our client hesitate to build any type of flower beds that might "trap" water against the foundation.

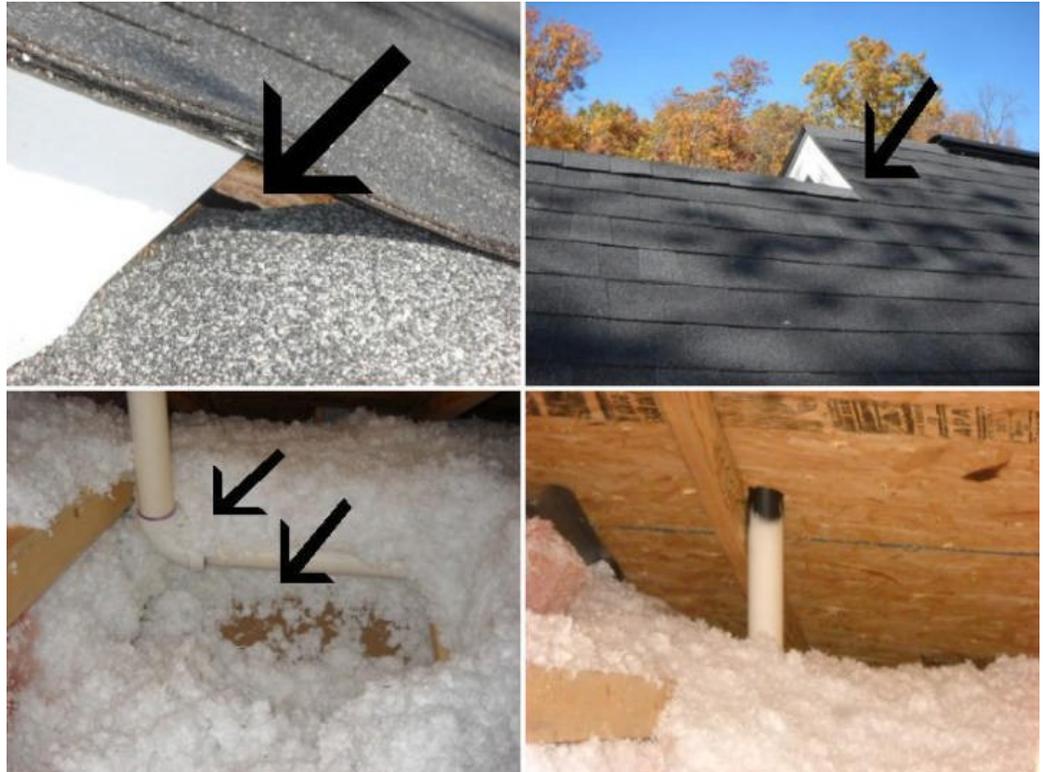
There is a stain from a previously wetted area in the ceiling of the rear right bedroom closet. The owner reports that this leak was active recently. The owner reports that the plumbing boot on the roof in this area was caulked and tarred.

Insulation was pulled back by suspected leak in the attic above the closet, no wetted insulation or damaged sheetrock was noted. No stained or wetted sheathing around the plumbing vent was noted.

Tarring or caulking a plumbing boot on the roof is not the proper way to correct a roof leak.

Possible causes: The roof leak could be caused at a distance from the actual wetted ceiling, traveling down roof from the leak location between the shingles and tar paper.

It is noted that a piece of flashing is missing at the roof peak where the higher roof line above the foyer joins the roof peak. This is a possible cause.

The plumbing vent at this location above the rear right bedroom closet has a elbow directly above the ceiling stain. It is possible that this elbow leaks in a heavy rain.

Some possible causes are offered below but this list is not all inclusive and a contractor should evaluate to determine the cause of the recent roof leak and perform repairs.

The plumbing roof vent might leak at this location. If so, the boot should be replaced.

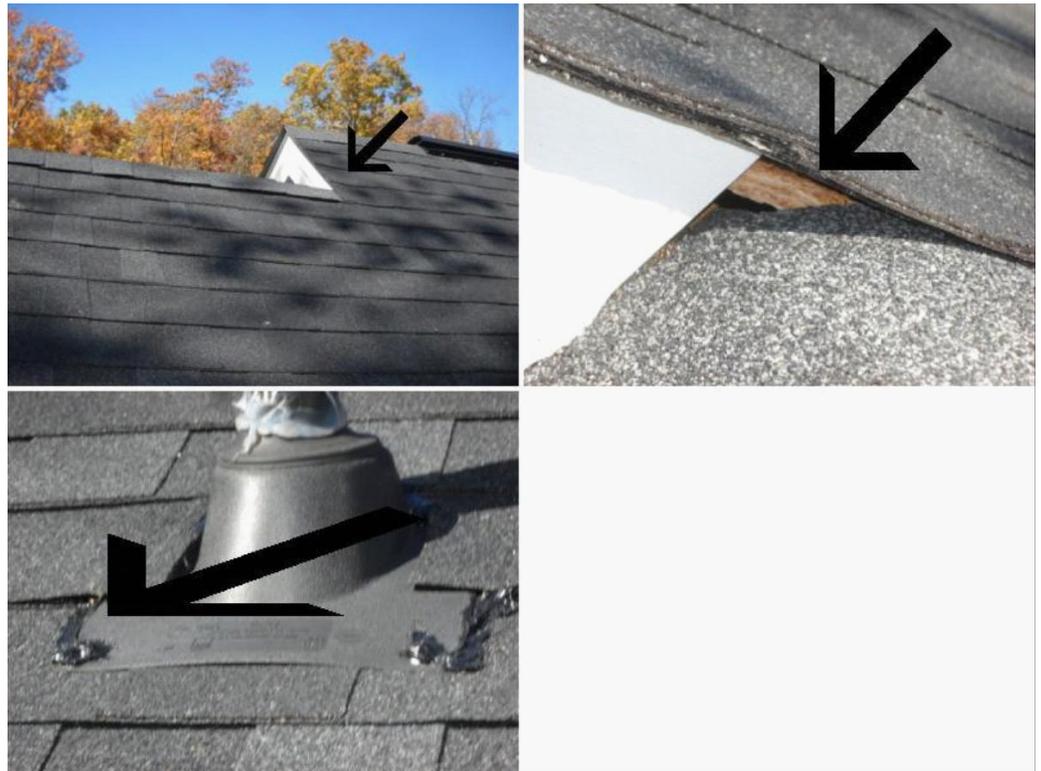
missing flashing at roof peak

There is a gap in the flashing at the roof peak where the higher foyer section of roof meets the peak on the right end of the foyer roof. Recommend properly flashing this area.

The plumbing vent above the right rear bedroom closet has been caulked and tarred in response to a roof leak. This is not the preferred method of correcting a leak, the boot should be replaced. If it is not desired to replace the boot this tar and caulk needs to be refreshed on a periodic basis as part of routine maintenance.

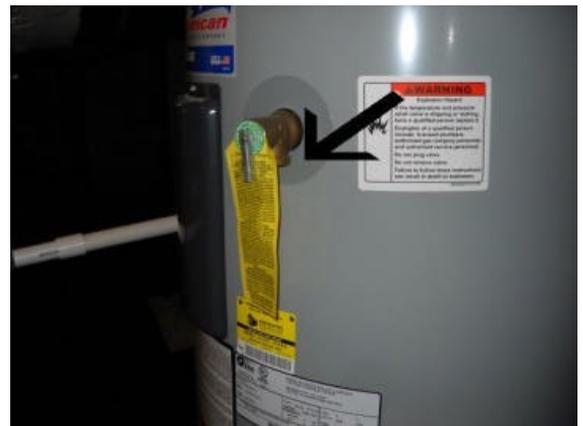
A cold water shutoff valve is installed. It is noted that the plastic PEX plumbing line is directly connected to the dielectric fitting at the top of the hot water taps on the water heaters. connection to the water heater.

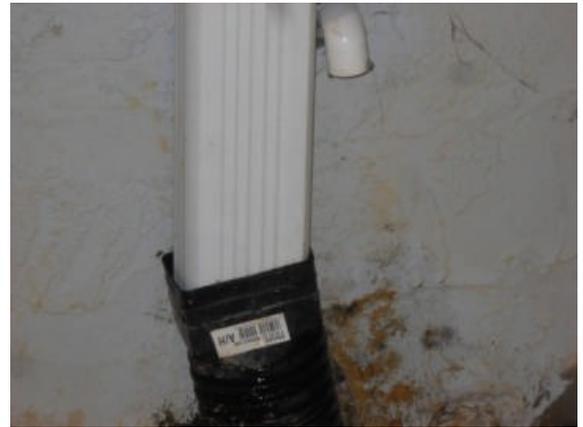
We suggest you consider extending the condensation line away from the foundation for both the bonus room heat pump and the main heat pump - on a typical summer day the A/C can produce several gallons of water. Recommend adding a trap on the main furnace condensate line.

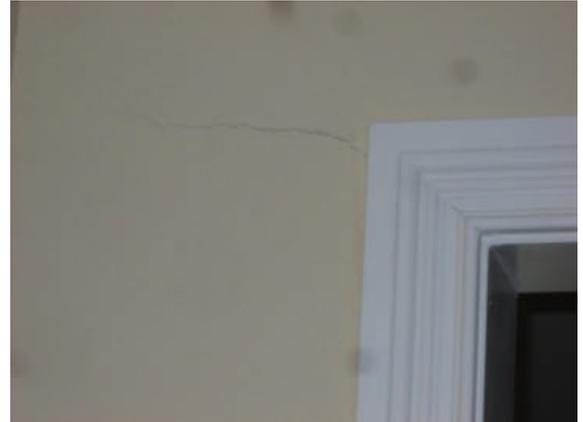
Drywall. Typical cracks noted above the door at the kitchen to the dining room Recommend sealing this crack. Typical cracks noted at junction of wall/ ceiling on left side of great room hv neck

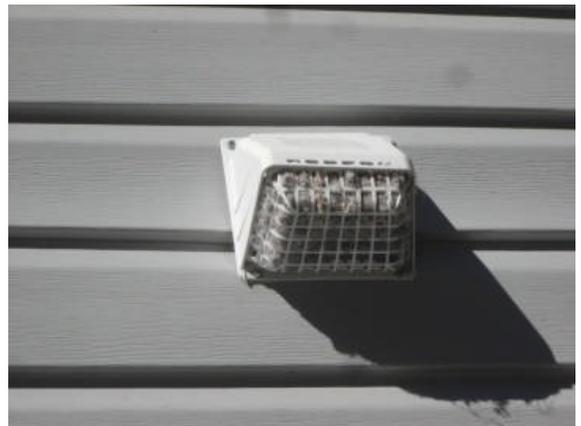
Plumbing appears serviceable, no leaks noted at time of inspection. Washer if installed was not tested. 220V Service-operational. Dryer vent is vented properly to exterior. The dryer exterior cap and screen is clogged, recommend cleaning the lint out and verifying the line is clear. This is a safety concern.

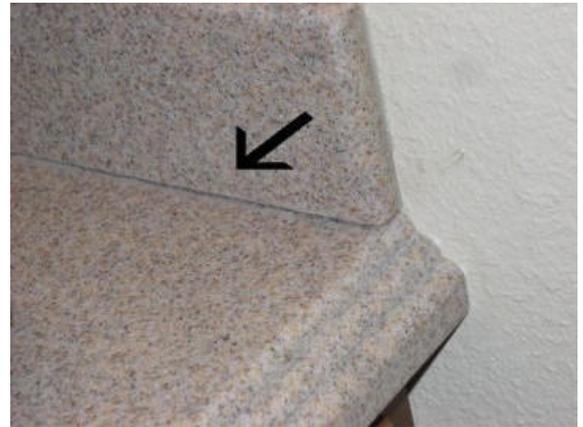
Appears serviceable, no leaks noted at time of inspection. Drain appear serviceable. Counters/cabinets appear serviceable. The sink has slightly settled, recommend caulking the joint between the counter top and side splash guard.

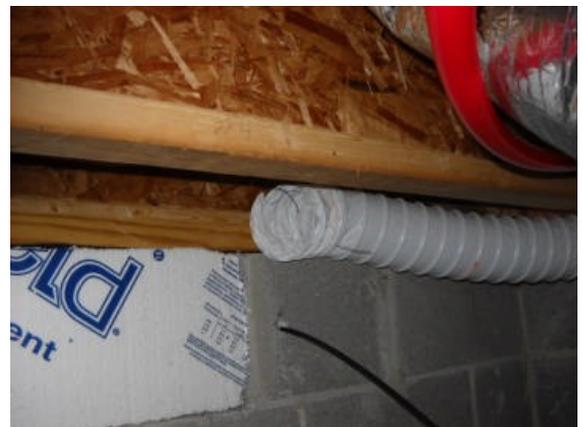
Basement bathroom vents into crawl space, recommend extending the vent line to the exterior.
