Inspection Report

Property Address:
2938 S West View St.
Los Angeles CA 90016

AmeriSpec Inspection Services

Date: 12/8/2021	Time: 10:00:00 AM	Report ID: 120821VM11
Property: 2938 S West View St. Los Angeles CA 90016	Customer: Brett Adelman and Anna Denecke	Real Estate Professional: Yona Lador Keller Williams Calabasas

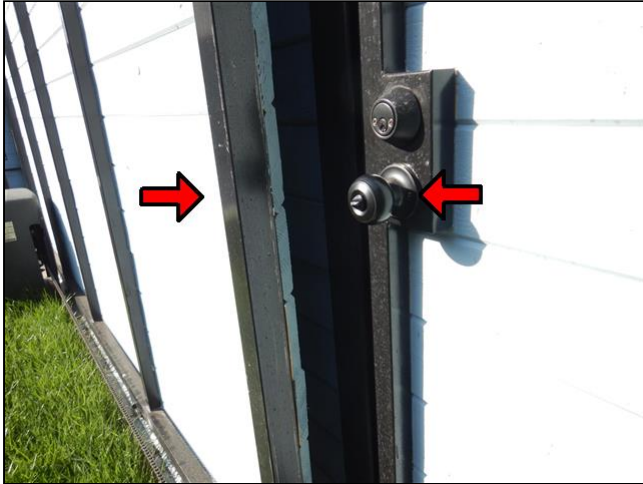
1.6 Item 1(Picture)

The front gate, when opened, comes into contact with the doorknob at the exterior entry door. Recommend further evaluation by a door/gate specialist for repairs/corrections to ensure proper operation.

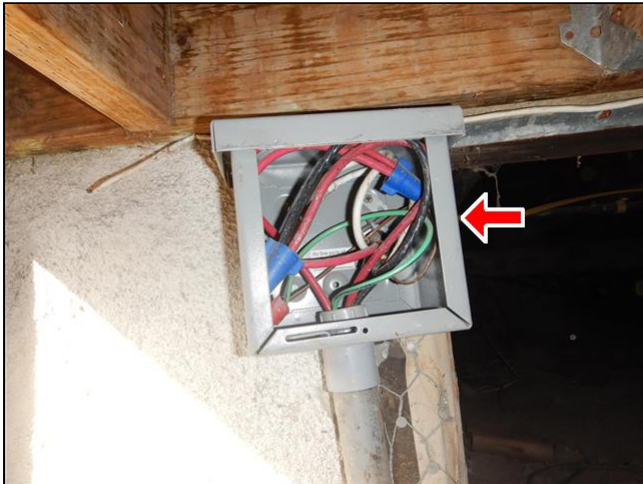
1.7 Item 1(Picture)

Open junction box was observed at rear of home, underneath the deck. Whenever an electric wire is cut and reconnected, the 'splice' should be encased in a covered junction box to prevent shocks and separation of the splice. Recommend cover be installed to ensure safety.

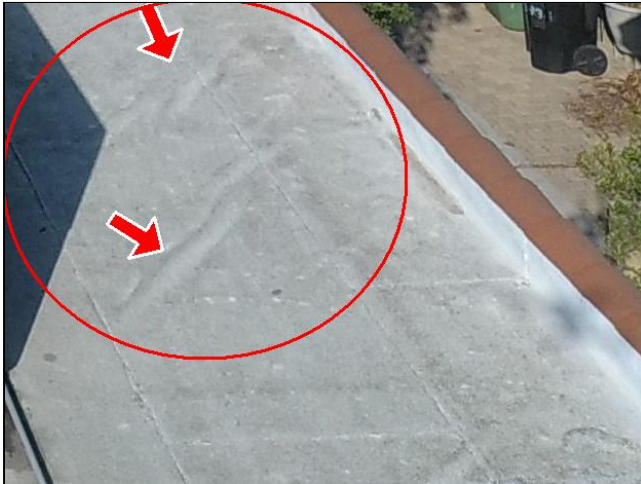
2.0 Item 1(Picture)

Buckle in membrane noted at left side of the roof. Recommend further evaluation by a licensed roofer for review and make the necessary recommendations for repairs or replaces as necessary.

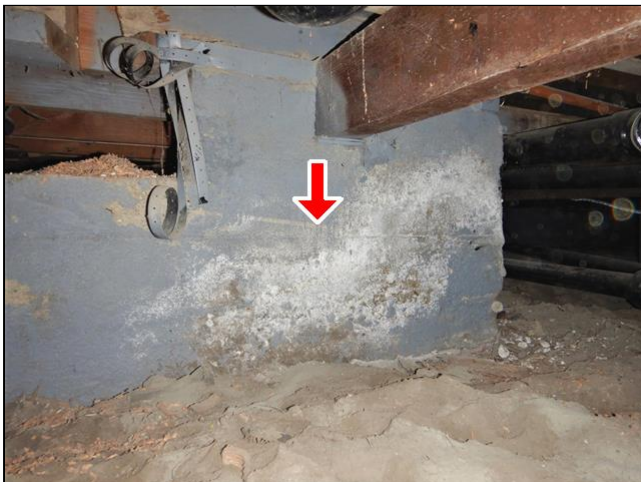
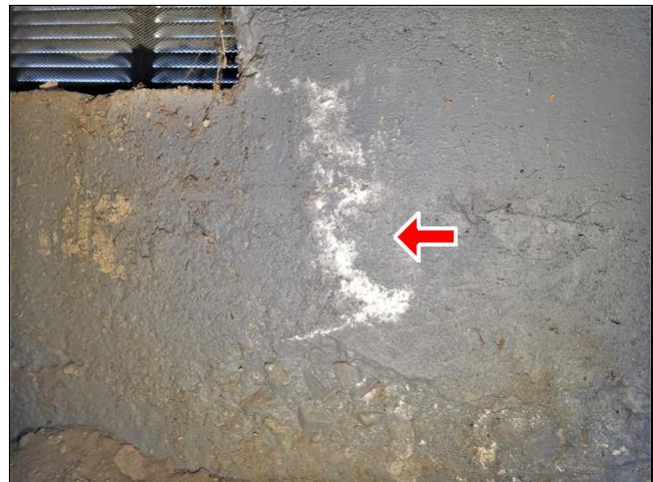
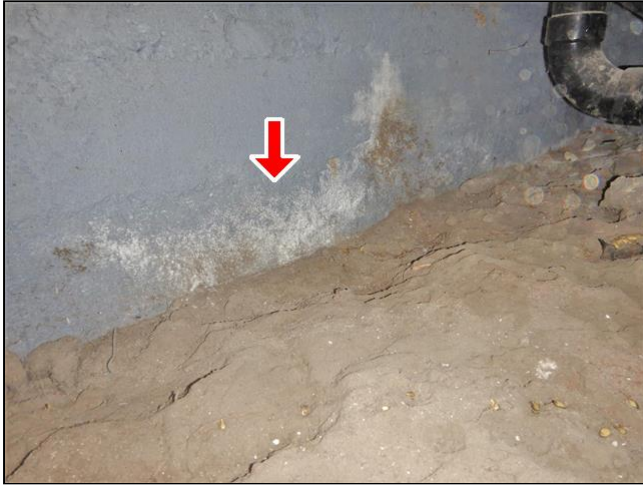
Efflorescence is present on the foundation on the crawlspace walls. Efflorescence is the salts left behind from moisture soaking into or passing through a masonry product. This moisture could adversely affect the foundation and/or the crawl space environment. A licensed structural engineer or a licensed general contractor specializing in crawl space moisture will need to determine the source of moisture and recommend or make necessary repairs.

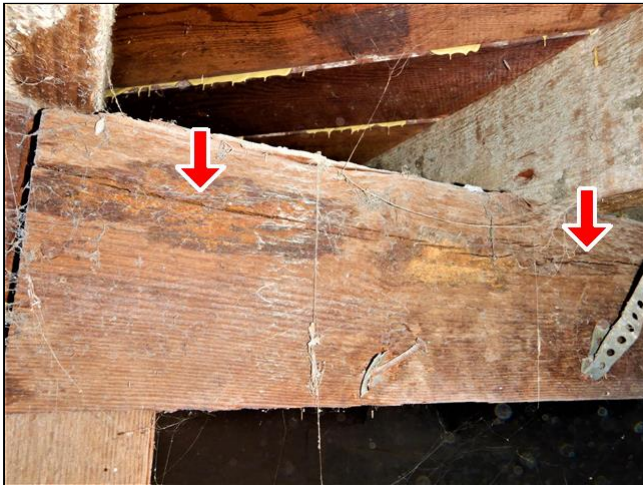
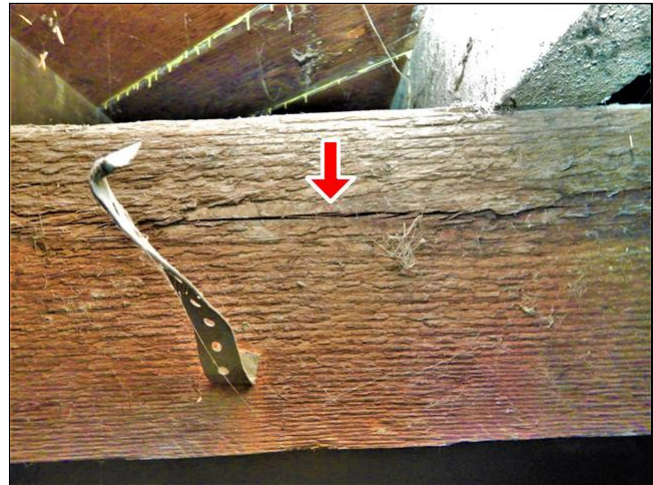
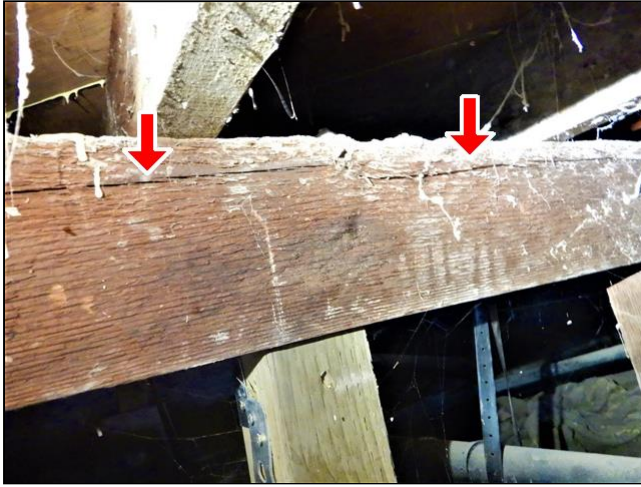
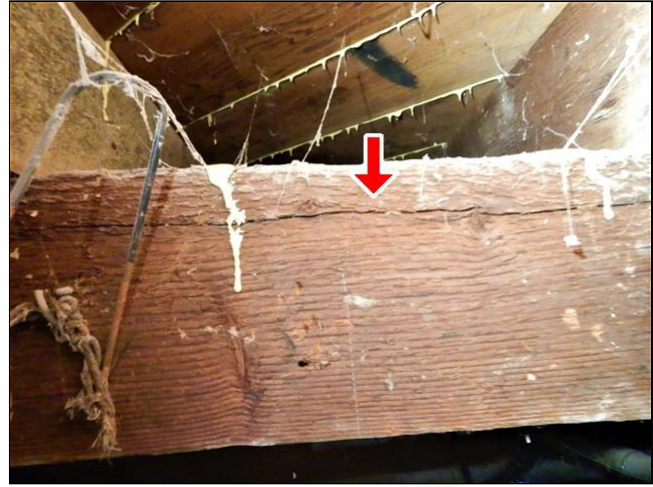
Cracking observed on one of the girder beams near the center of the crawlspace. Recommend further evaluation by a structural engineer for repairs/corrections as needed.

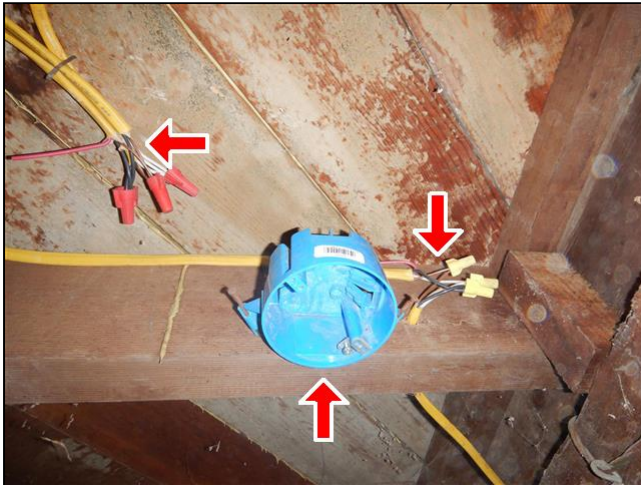
3.6 Item 1(Picture)

(1) Exposed wiring observed in the crawlspace near right side of home. These should be encased in a junction box. Recommend further evaluation by a licensed/qualified electrician for repairs/corrections to ensure safety.

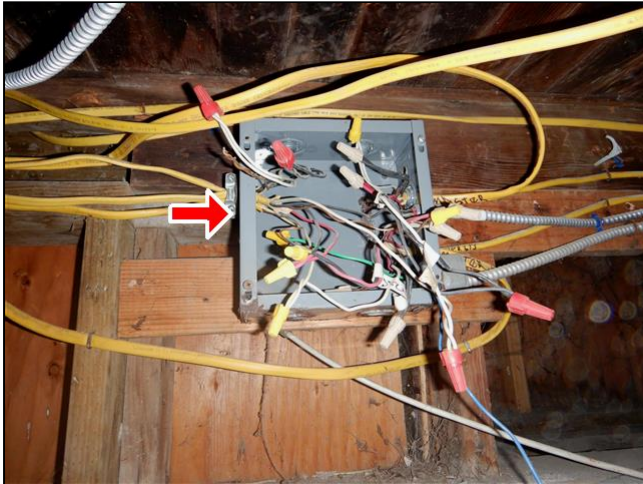
3.6 Item 2(Picture)

(2) Open junction box observed in the crawlspace at rear of home (through entrance under deck). Whenever an electric wire is cut and reconnected, the 'splice' should be encased in a covered junction box to prevent shocks and separation of the splice. Recommend cover be installed to ensure safety.

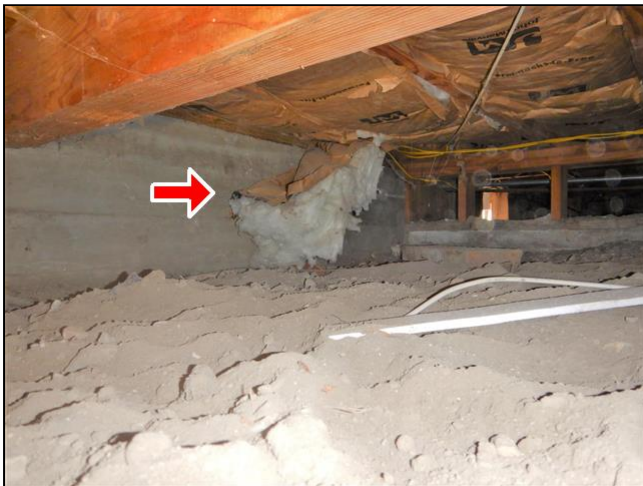
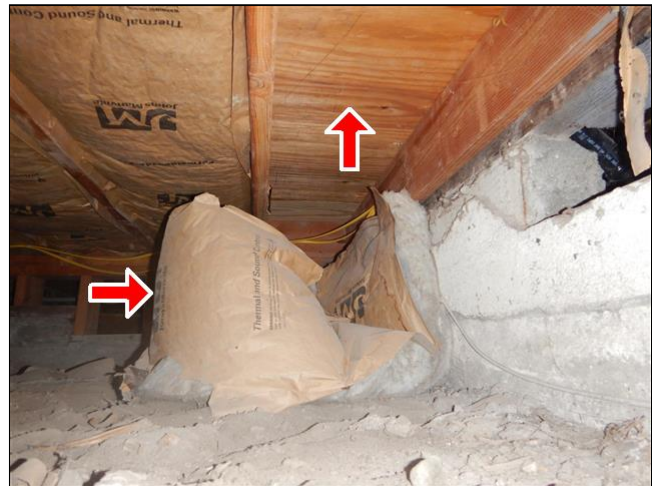
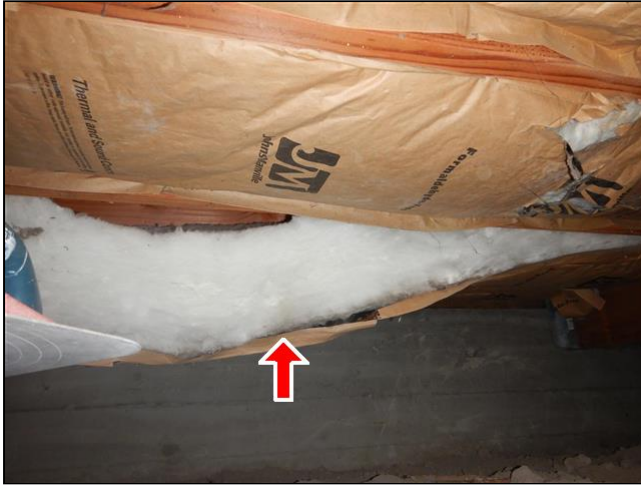
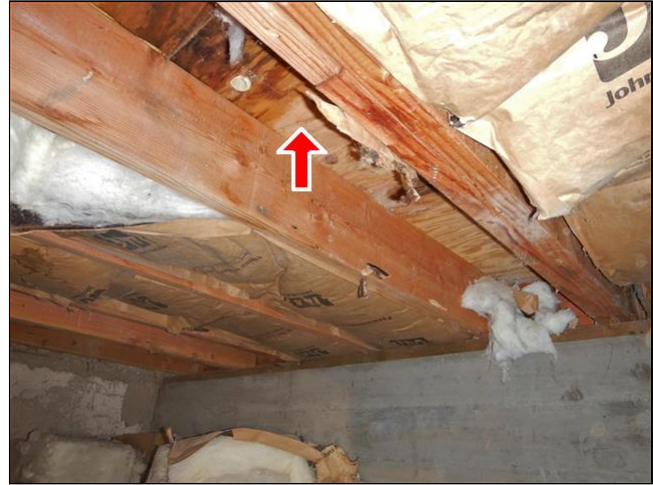
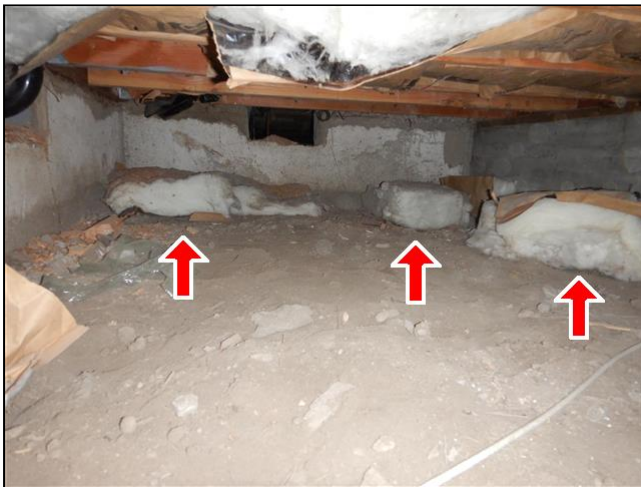
Loose/missing sections of batt insulation observed in section of the crawlspace where insulation has been installed (left side of home). Recommend review for repairs/corrections as needed.

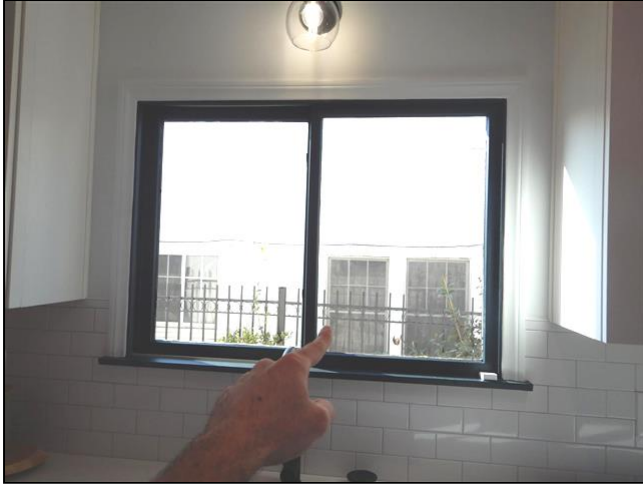
9.3 Item 1(Picture)

Unable to open window above sink in kitchen. Possibly painted shut. Recommend further evaluation by a window specialist for repairs/corrections to ensure proper operation.

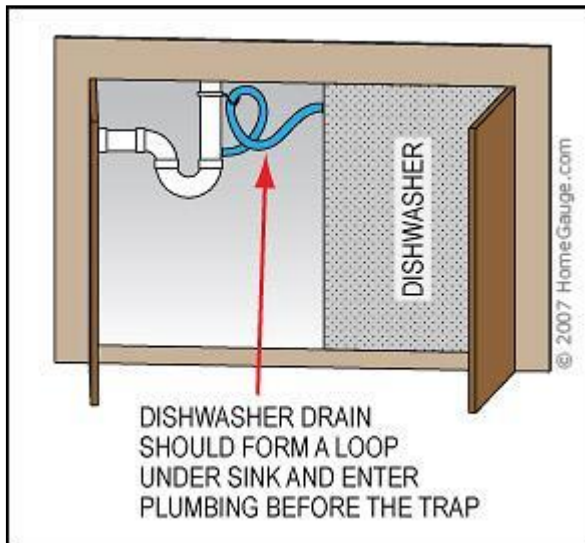
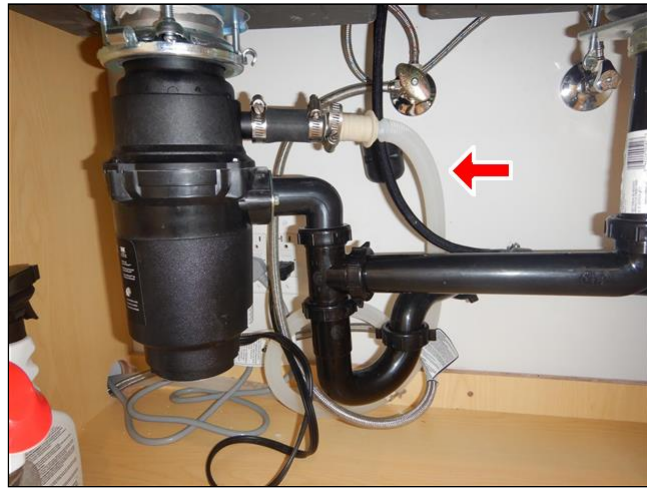
No loop in drain line. The dishwasher drain line needs to be looped upward near the top of the cabinet underside in order to prevent possible contamination of clean dishes which can occur when water from the sink flows into the dishwasher. This may not have been required when dishwasher was installed, recommend the installation of a drip loop as a plumbing upgrade.

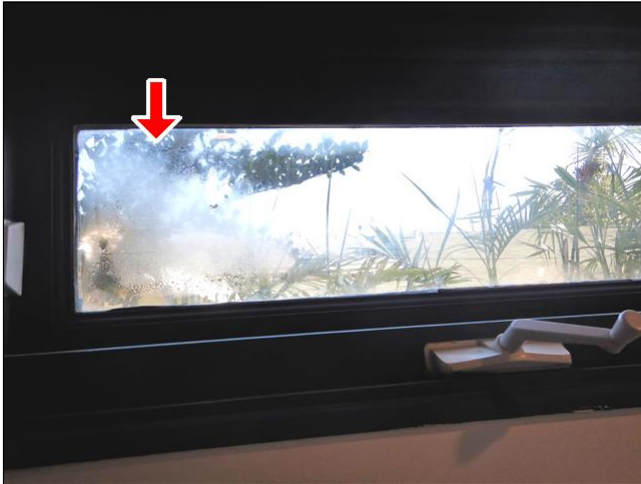
10.4 Item 1(Picture)

(1) Fog and condensation was noted in the double glazed insulated window pane for the left side window in bathroom #2. This indicates a broken seal which will reduce visibility and the insulating capability of this window. To restore visibility and regain the insulating capability, replacement of this window pane is required.

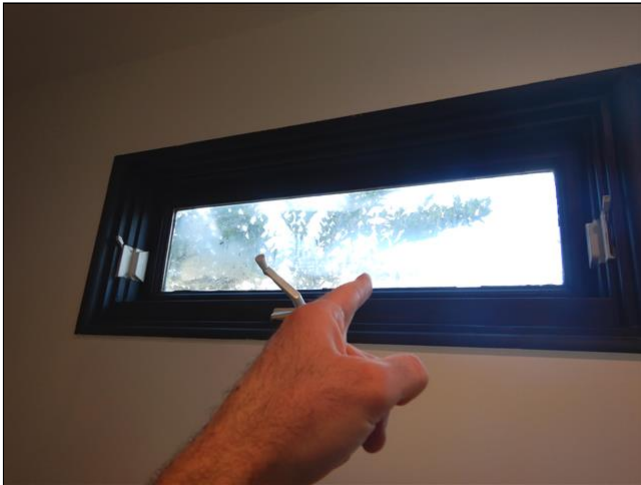
10.4 Item 2(Picture)

(2) The left side window in bathroom #2 (master) did not open/close properly when tested. Recommend further evaluation by a window specialist for repairs/corrections as needed.

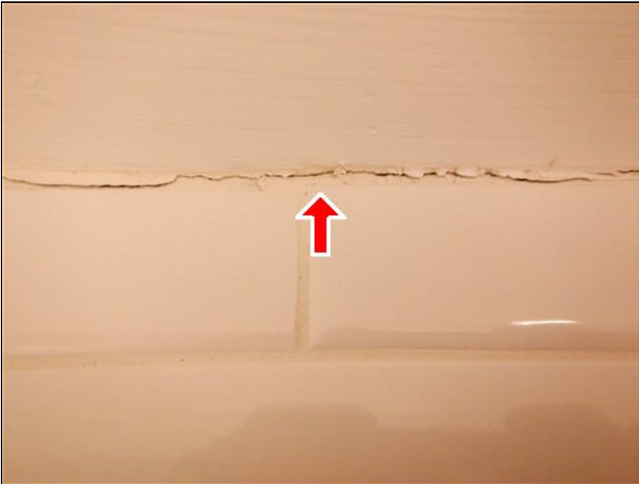
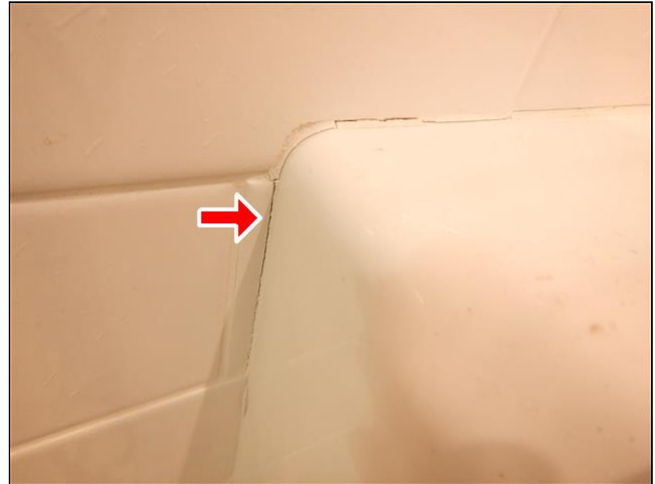
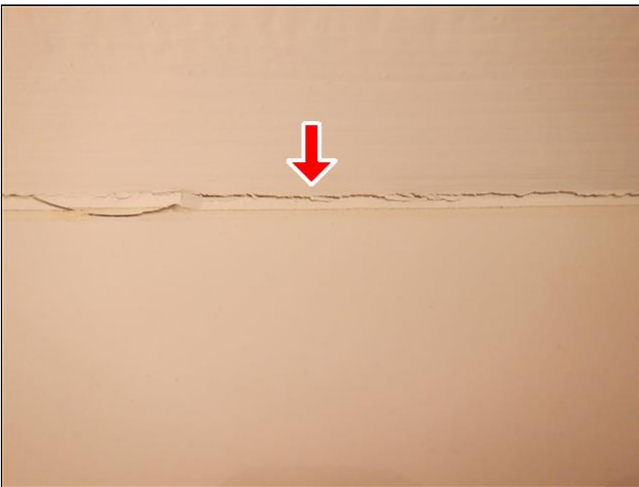
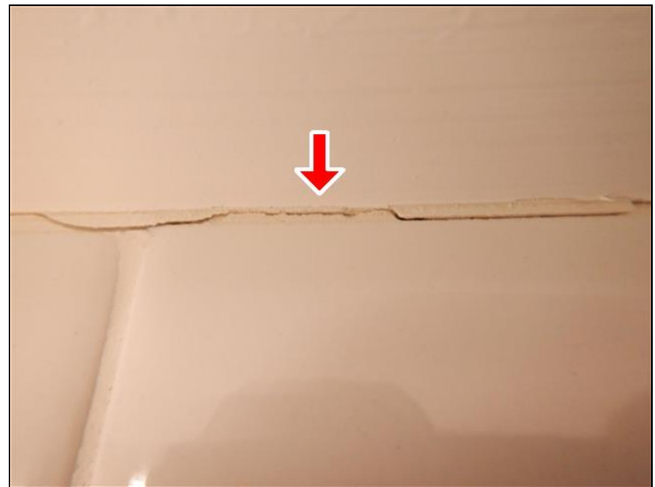
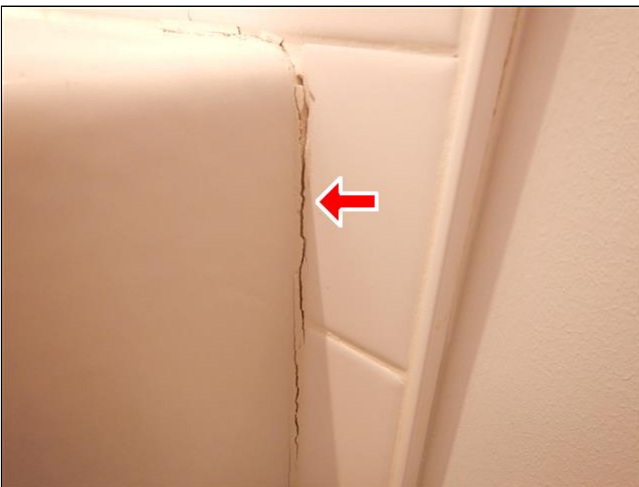
(1) The tile edges of the tub/shower walls in bathrooms #1 and #3 should be re-grouted/sealed to prevent moisture penetration. Failure to keep walls sealed can cause deterioration and moisture damage to the interior walls, which is not always visible to the inspector at the time of inspection.

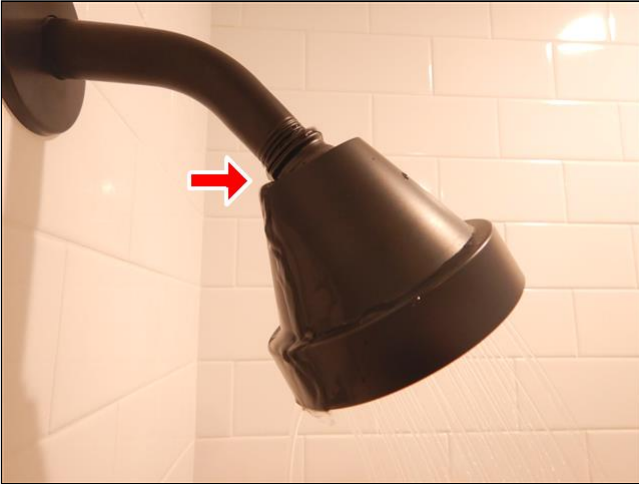
10.9 Item 6(Picture)

(2) Shower head leaks at the connection joint, noted in bathroom #1. Recommend review for repairs/corrections as needed.

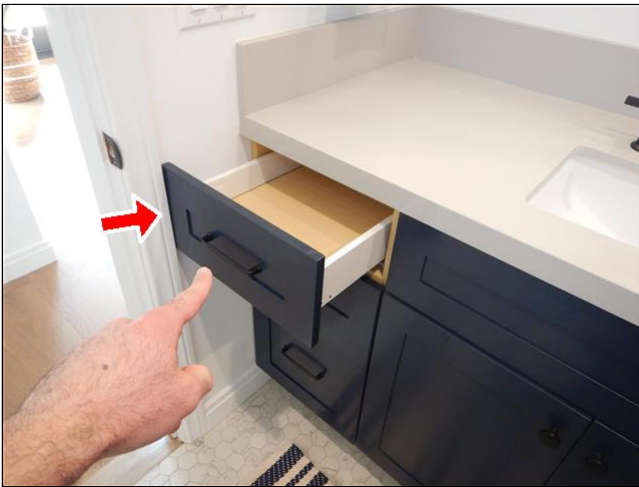
10.12 Item 1(Picture)

Left side cabinet drawers in bathroom #2 (master) do not open all the way due to being obstructed by the door trim. Recommend review by a licensed/qualified contractor for repairs/corrections to ensure proper operation.

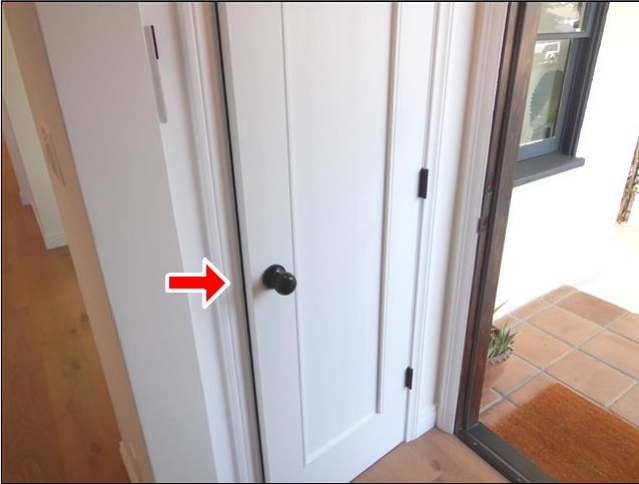
12.4 Item 1(Picture)

The hall closet door near the main entry way does not latch. Recommend review by a door specialist for repairs/ corrections as needed.

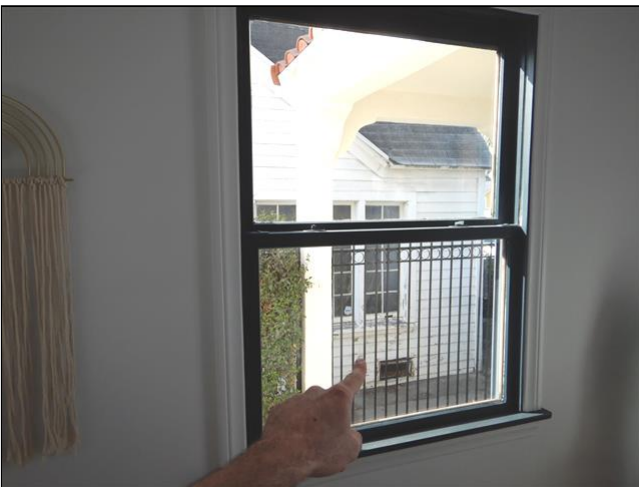
12.5 Item 1(Picture)

All windows throughout the interior, except in bedroom #2 and the added living area, are missing the screens. Recommend consult sellers as to the possibility of stored screens, or review for replacing as needed.

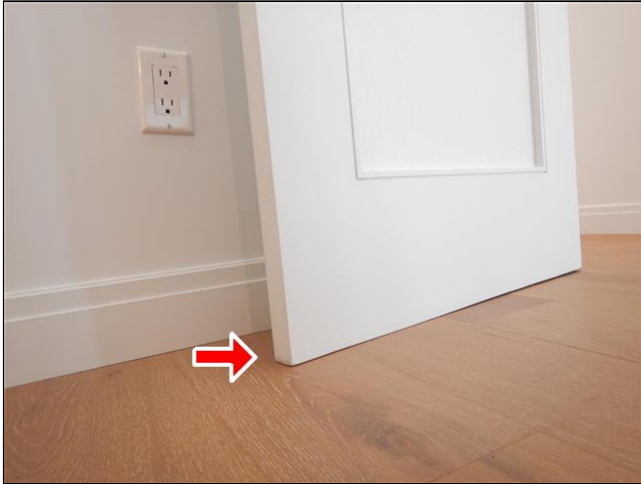
13.3 Item 1(Picture)

The bedroom #3 (master) door rubs the floor when opened. Recommend review by a door specialist for repairs/ corrections as needed.
