SUMMARY REPORT

Doc #:	072519DD25	Client Name:	AmeriSpec
Dwelling Address:	1600 Any Ln Anytown PA 19000	Inspector:	David A Dibelius

Inspection Report

1600 Any Ln
Anytown PA 19000

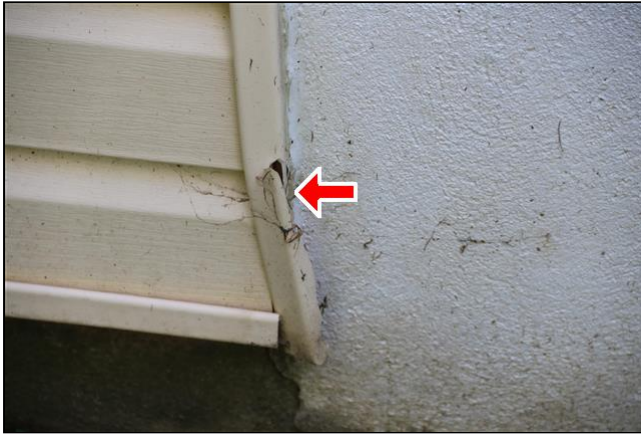
2.2 Exterior Wall Cladding**Comments:** Repair or Replace

(2) Damaged siding observed. Primarily a cosmetic concern. Recommend corrections as desired.

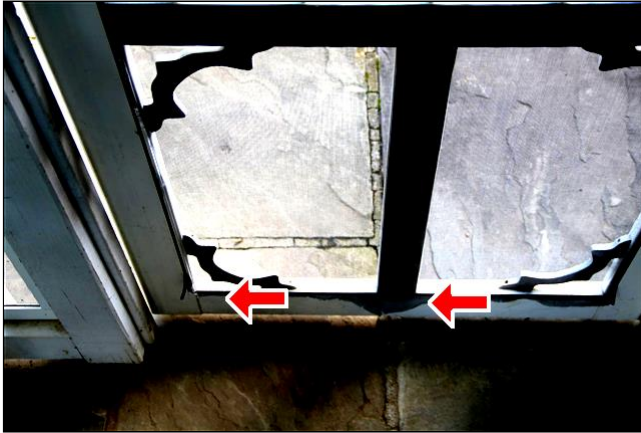
The screen(s) were damaged /missing on the screened enclosure, repairs/replacements needed.

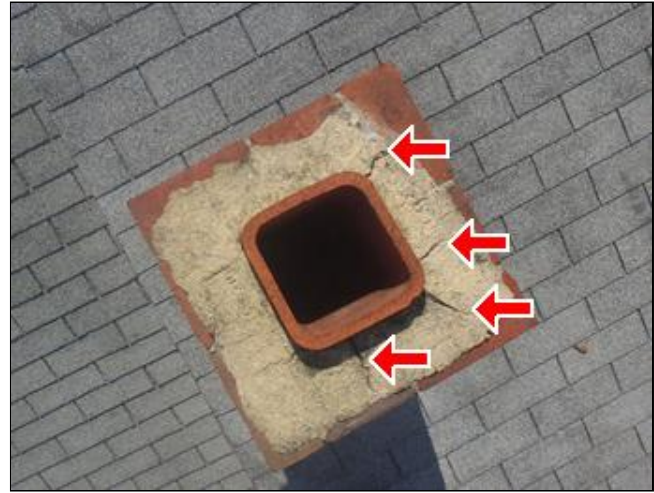
5.0 Chimney Conditions

Chimney crown deterioration observed. Suggest rebuilding weather cap (chimney crown) to reduce opportunity for water infiltration and damage. This is a common maintenance item that is often neglected by homeowners; you should make a crown inspection part of your routine seasonal maintenance checklist.

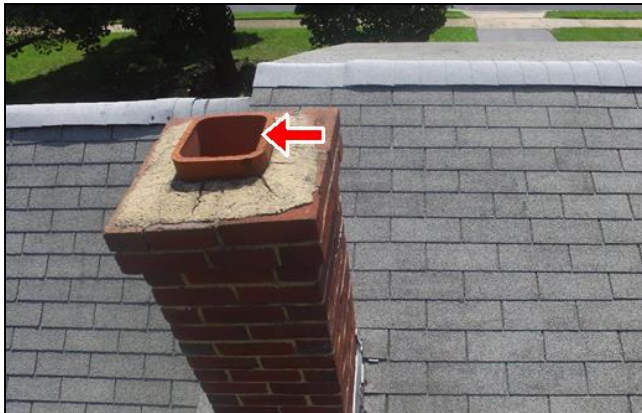
5.3 Spark Arrestor / Rain Cap

No chimney rain cap observed, suggest installing a chimney rain cap to prevent the entrance of the elements, local wildlife, and to preserve the life of the chimney as well as minimize maintenance.

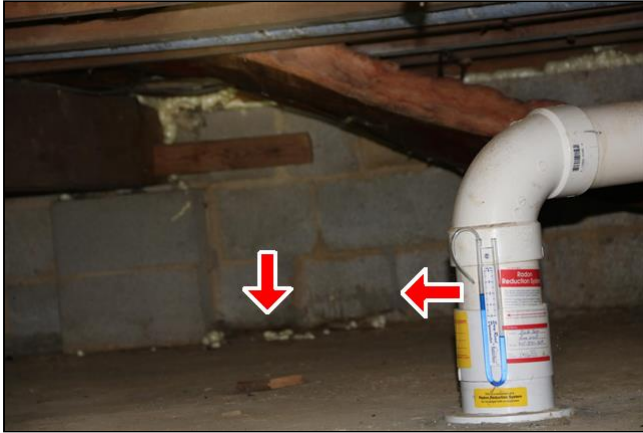
6.3 Walls (Basement and Crawlspace)

Evidence of possible past moisture observed. No active leaks observed at time of inspection. Recommend consulting seller for more information or a licensed contractor if a more detailed report is desired.

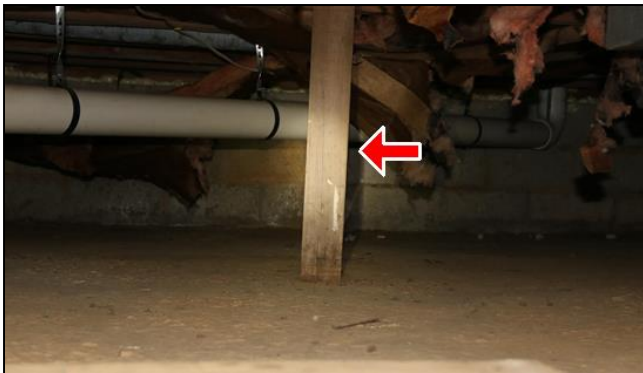
6.5 Columns or Piers (Basement and Crawlspace)

Additional support piers have been added at least in one area within the crawlspace. Piers appear to have been added to assist in leveling floor. While this does not appear to be a structural concern at this time, pier appears to have been installed by less-than-professional means. Client is advised to consult sellers or a building contractor for additional information.

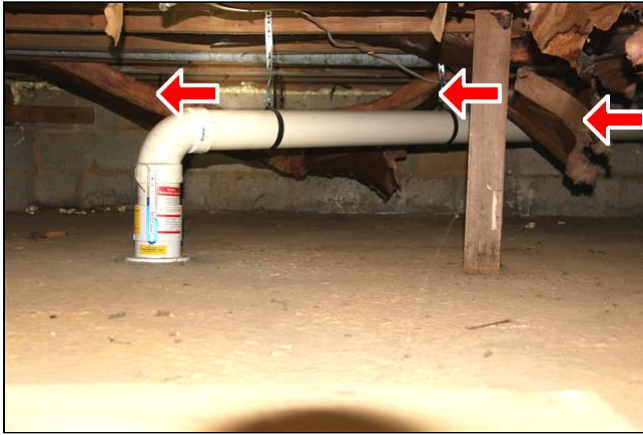
6.8 Insulation Under Floor System

Loose/missing sections of insulation observed in the crawlspace, suggest securing or replacement as necessary.

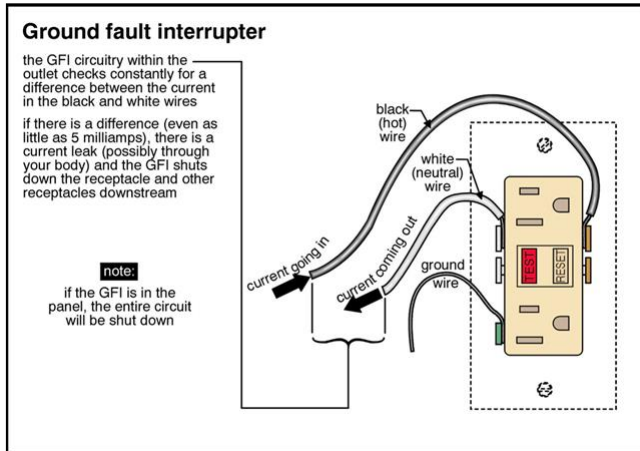
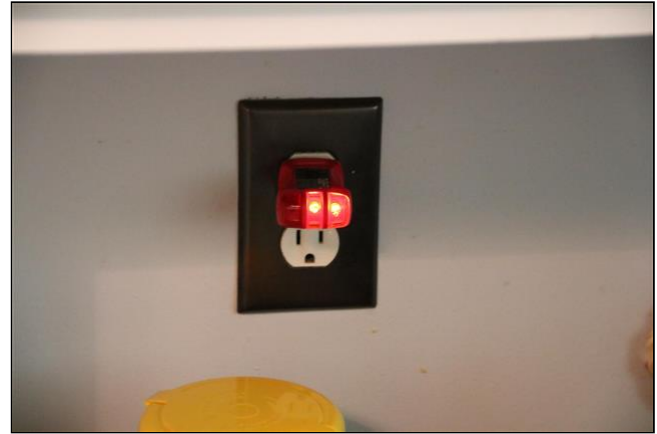
Not all receptacles are ground fault circuit interrupter (GFCI) protected (receptacle left of the sink). This may not have been required when home was built; client is advised to install ground fault circuit interrupter outlets as a safety enhancement.

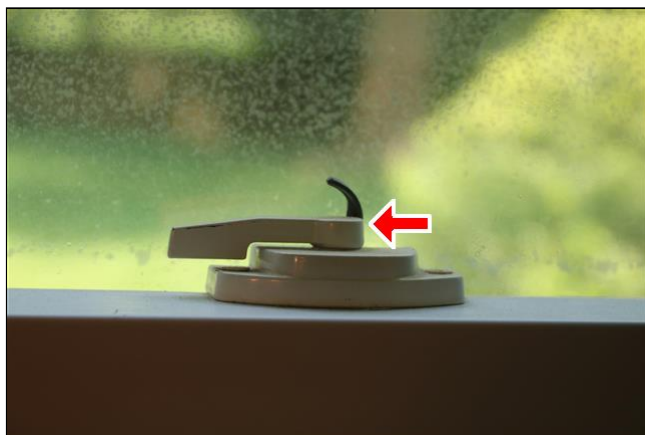
Window lock(s) are damaged in the half bathroom. Corrections are needed for security.

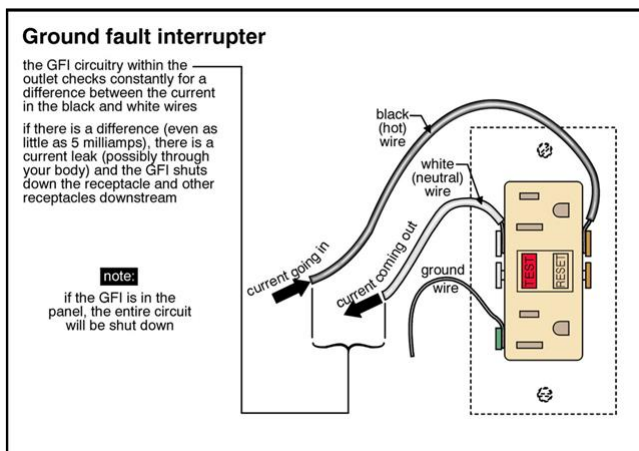
Not all receptacles are ground fault circuit interrupter (GFCI) protected. This may not have been required when home was built; client is advised to install ground fault circuit interrupter outlets as a safety enhancement.

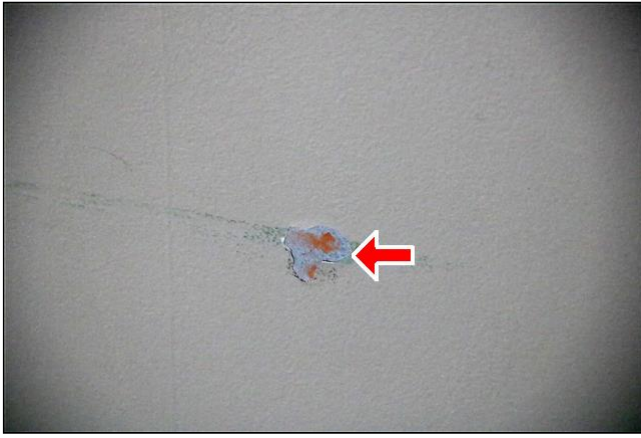
Minor cosmetic damage/chipped paint observed in master bedroom. Recommend corrections as desired by client.

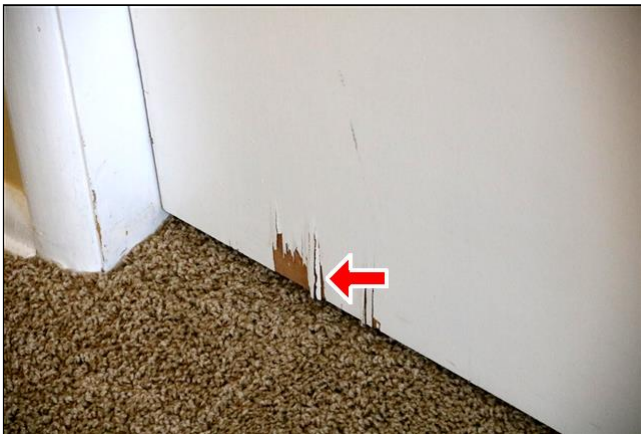
The left rear bedroom door is damaged. Primarily a cosmetic concern. Recommend repair as desired.

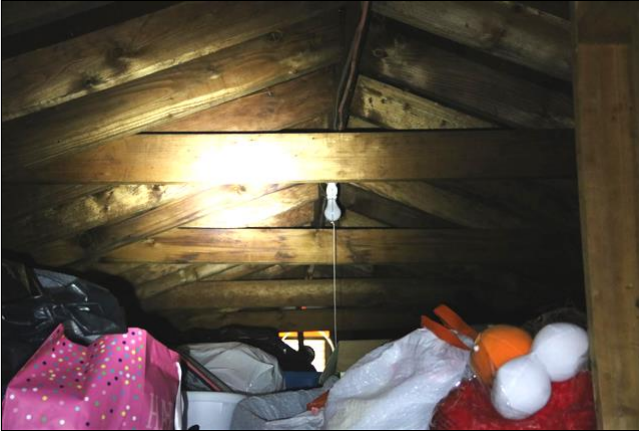
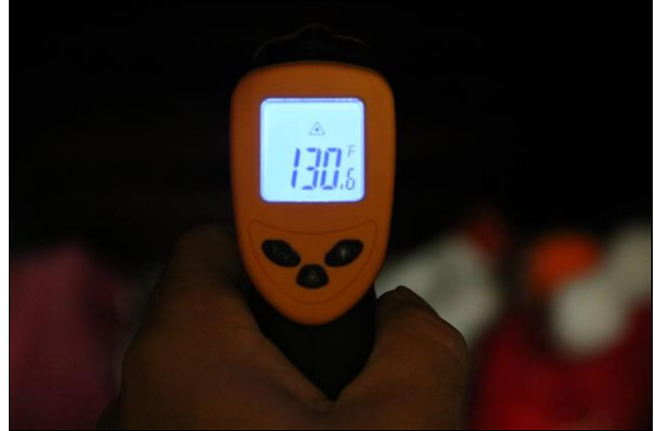
The attic area is inadequately vented. Temperatures in excess of 130 degrees. This can cause moisture/condensation build-up, which can cause damage/deterioration to the structure framing in the attic. Personal item storage may be a contributing factor to this issue. Suggest further review by a licensed contractor prior to closing for repairs/replacement as needed to ensure proper attic venting.
