Doc #:	2008	Inspector:	Paul J. Binkley, PCLA Licensed Home Inspector #10654
Date:	11/6/2008		
Dwelling Address:	Example Monroe, LA 71201		
Client Name:	Home Buyer		
Client's Agent:	Ron Realtor	Real Estate Company:	ABC Realty

AmeriSpec Home Inspections

AmeriSpec General Home Inspection

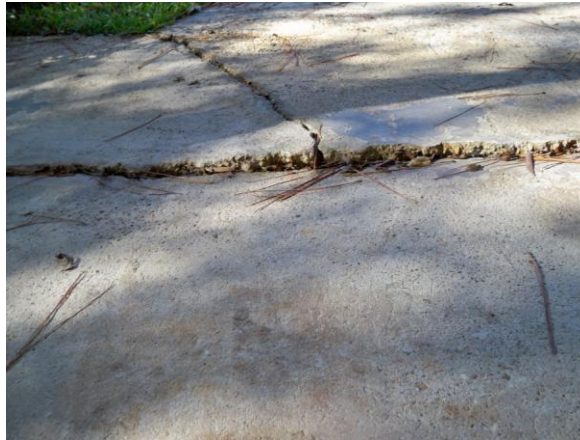
Step #	Component	Comments
1101	Driveway	<p>Safety. Concrete. Common cracks observed, primarily a cosmetic concern. Suggest sealing all cracks in concrete/asphalt/brick surfaces to prevent water penetration as a routine maintenance effort.</p> <p>Possible trip hazard noted. This is a safety concern. Suggest repair/replacement as needed to ensure safety.</p>

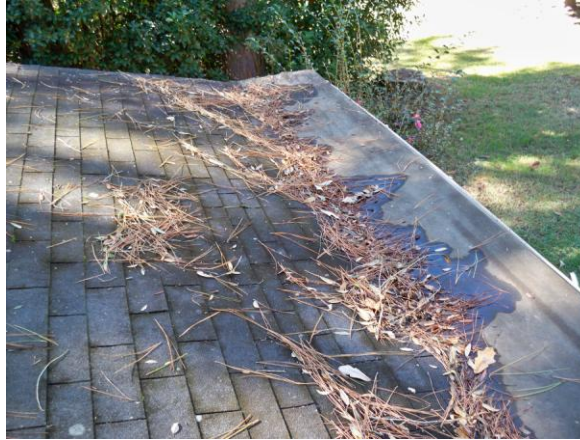
- 1205 Conditions Debris observed on the roof/valleys limits view of roof and prevents the roof from draining or drying out. Debris in the valleys may cause water to dam and flashing(s) to leak. Suggest periodic removal of debris as part of routine maintenance.

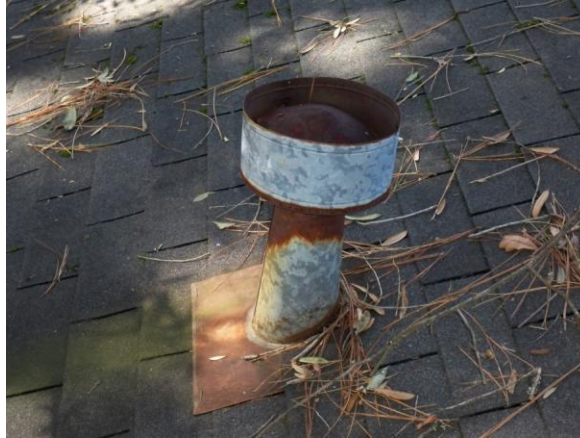
1207	Roof Comments	Exhaust vent stacks and caps have rust present. The stack and caps are still functional; suggest monitoring this condition as an annual routine maintenance item.
------	------------------	---

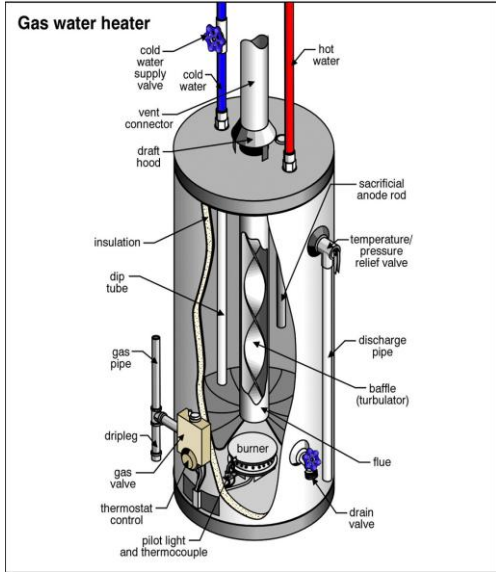
Step #	Component	Comments
2101	Location of unit	The water heater is located in the carport storage room.
2102	Water Heater Design Type	Natural gas.
