## "About the House"

Inspection #: ----13128

Date: /2019

**AmeriSpec****GENERAL CONDITIONS**

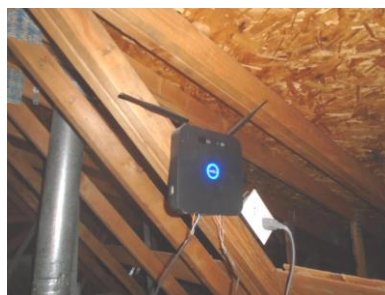
1915. Heater & CO  
Comments

1. Two C.O detection units are provided in this structure.
2. A wireless control system is provided in the attic for both systems. We advise reviewing product operations.
