## **AmeriSpec Inspection Services**

## AmeriSpec General Home Inspection

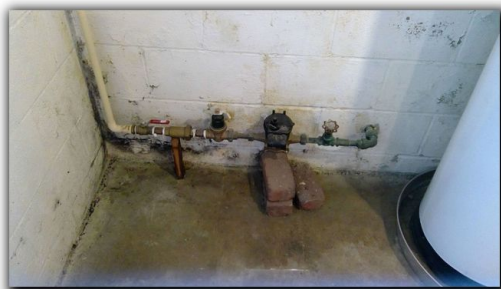
**1. Main Shutoff**

Shutoff valve is not tested. **Shut Off Valve Location: Basement**

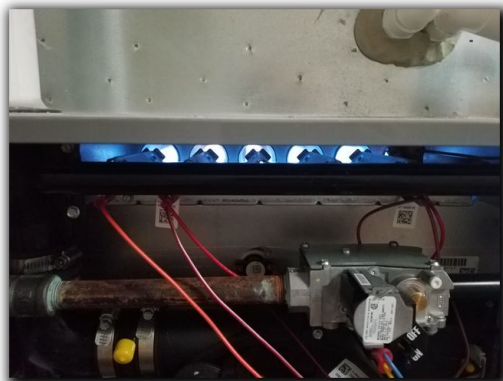
| 2. | <b>Conditions</b> | The furnace was activated to check the operation of the burner/exhaust and blower. A detailed review of the heating capacity of this unit is beyond the scope of this inspection and we make no warranty as to the adequacy of the system. |

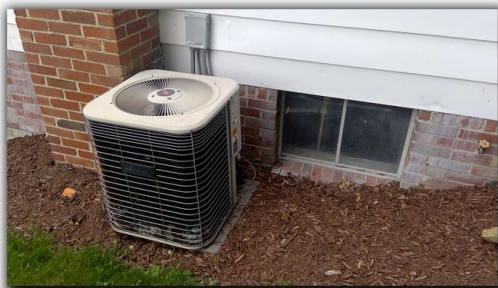
| 1. | <b>General Condition</b> | The evaluation of the cooling system is both visual and functional, provided power and/or fuel is supplied to the unit. The air conditioner is tested using normal operating controls. at the: furnace. <b>Energy Source: Electric with disconnect</b> |

| 2. | <b>Temperature/Condensing Coil</b> | <b>A/C Tested and Operational:</b><br>The air conditioner is activated to check the operation of the motor and the compressor. The temperature difference is within the recommended range. As a detailed review of the cooling capacity of this unit is beyond the scope of this inspection, we make no warranty as to the system's adequacy. |

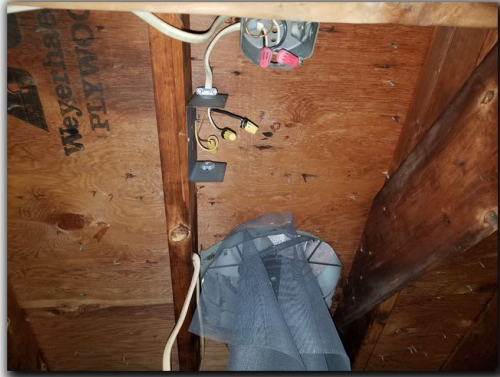
6.	<b>Ventilation</b>	The attic ventilation is: Ridge and Soffit
7.	<b>Electrical</b>	<b>1. Repair/Replace:</b> <b>Open electrical wire splice was present at the attic fan, which could be a safety concern. Whenever electrical wiring is cut and re-connected, the splice should be encased in a covered junction box to prevent shocks and separation of the splice. This type of electrical repair should be performed by a qualified electrician.</b>
