Inspection Report

Property Address:
2938 S West View St.
Los Angeles CA 90016

AmeriSpec Inspection Services

Date: 12/8/2021	Time: 10:00:00 AM	Report ID: 120821VM11
Property: 2938 S West View St. Los Angeles CA 90016	Customer: Brett Adelman and Anna Denecke	Real Estate Professional: Yona Lador Keller Williams Calabasas

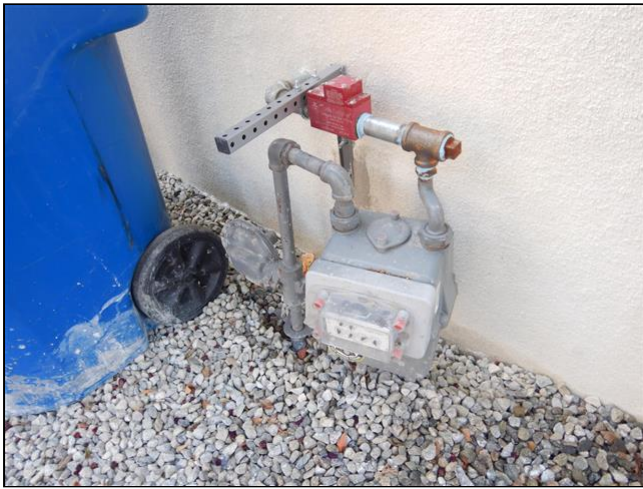
1.8 Item 1(Picture)

The main fuel shut off is at gas meter, located at left side.

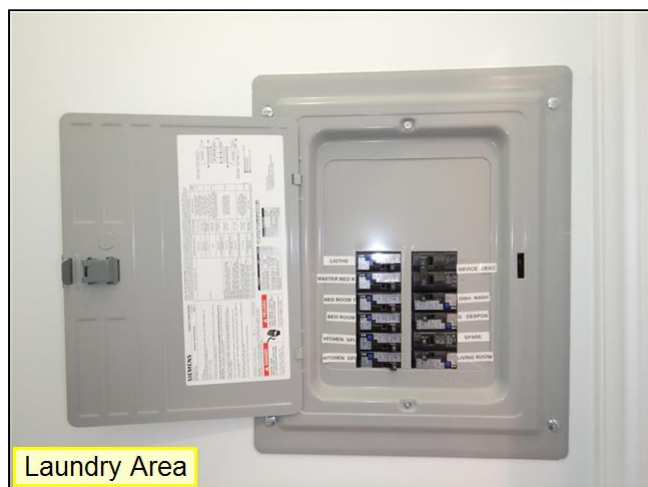
5.3 Item 1(Picture)

The sub panel boxes are located at the Laundry Room and Bedroom #4 (added living area).

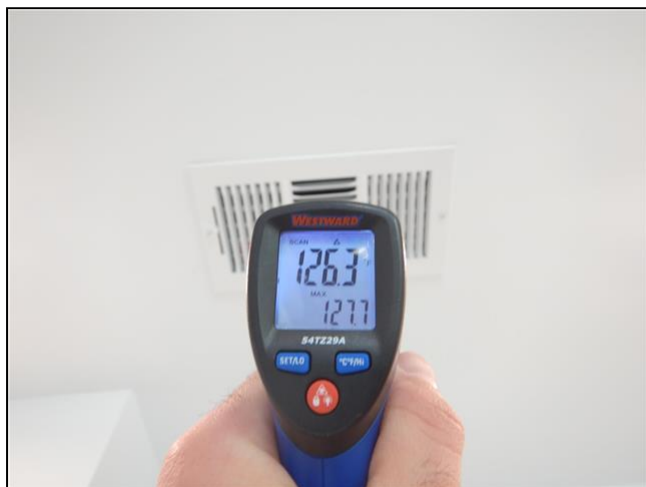
6.0 Item 1(Picture)

The American Standard Gas Forced Air Furnace and Wall Mounted Heat Pump were tested using normal operating controls and functioned properly at time of inspection. Due to inaccessibility of many of the components of these units, the review is limited. Holes or cracks in the heat exchanger (if applicable to this type system) are not within the scope of this inspection as heat exchangers are not visible or accessible to the inspector. Units were operated by the thermostat and remote control. As with all mechanical equipment the units can fail at anytime without warning. Inspectors cannot determine future failures. If a detailed inspection is desired, a licensed heating contractor should be consulted prior to closing to ensure proper and safe operation of these units.

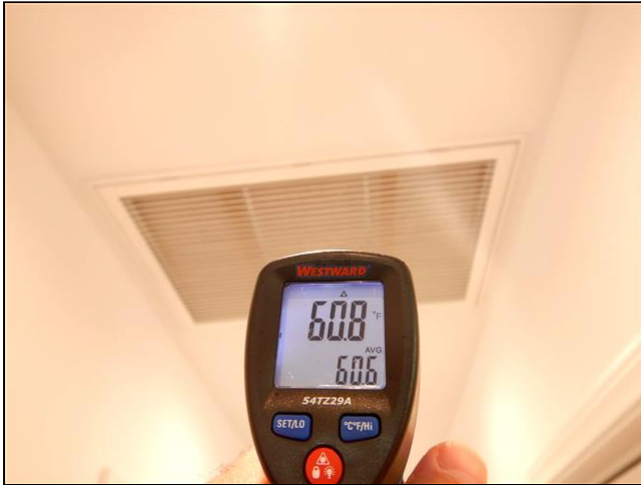
7.1 Item 1(Picture)

A temperature drop was performed across the evaporator coil of this unit. When tested, temperature at return register was 60.8 degrees, temperature at supply was 46 degrees, a difference of 14.8 degrees which is in the 14 to 22 degree normal operating range. Unit functioned properly when tested and was serviceable at time of inspection.

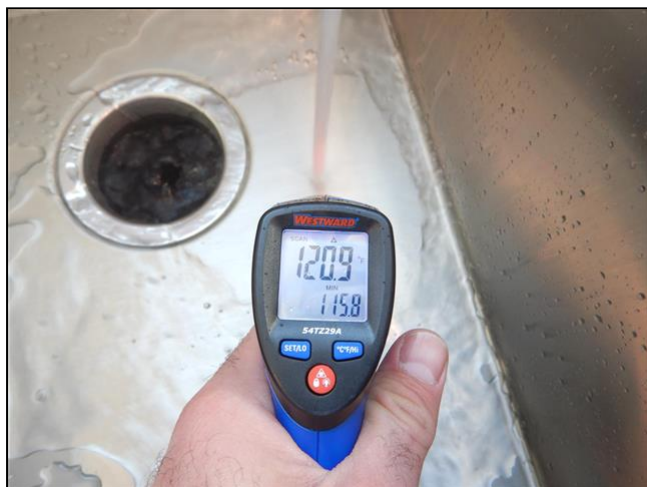
8.6 Item 1(Picture)

The water temperature at time of inspection was 120.9 degrees, which is in the normal operating range of 120 to 130 degrees.
